ARIZONA DEPARTMENT OF TRANSPORTATION

REPORT NUMBER: FHWA-AZ-9403

PERFORMANCE EVALUATION OF PORTLAND CEMENT CONCRETE PAVEMENT JOINT SEALANTS

Final Report

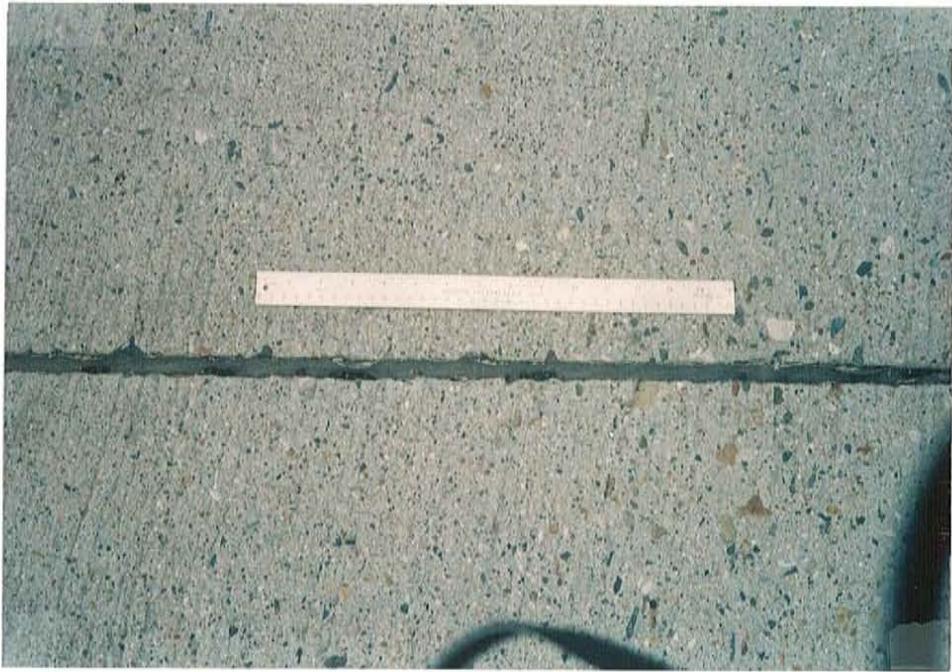
Figures 5 and 6 show a typical surface appearance of the silicone and asphalt-based sealants in April 1994. The results of data analysis for the 1994 field survey are summarized in Table 3 and depicted in Figures 7 through 10. The analysis indicated that eight years after the installation of the test section:

1. All sealants had good flexibility.
2. The average slab faulting was about 0.2 in. There was no significant difference in average faulting measurements among joint sets for the different sealants.
3. Dow Corning 888, Superseal 888, CrafcO Roadsaver and Meadow Sof-seal sealants had experienced an average adhesive failure (partial and full

Figure 5: Typical appearance of silicone sealant joints after eight years

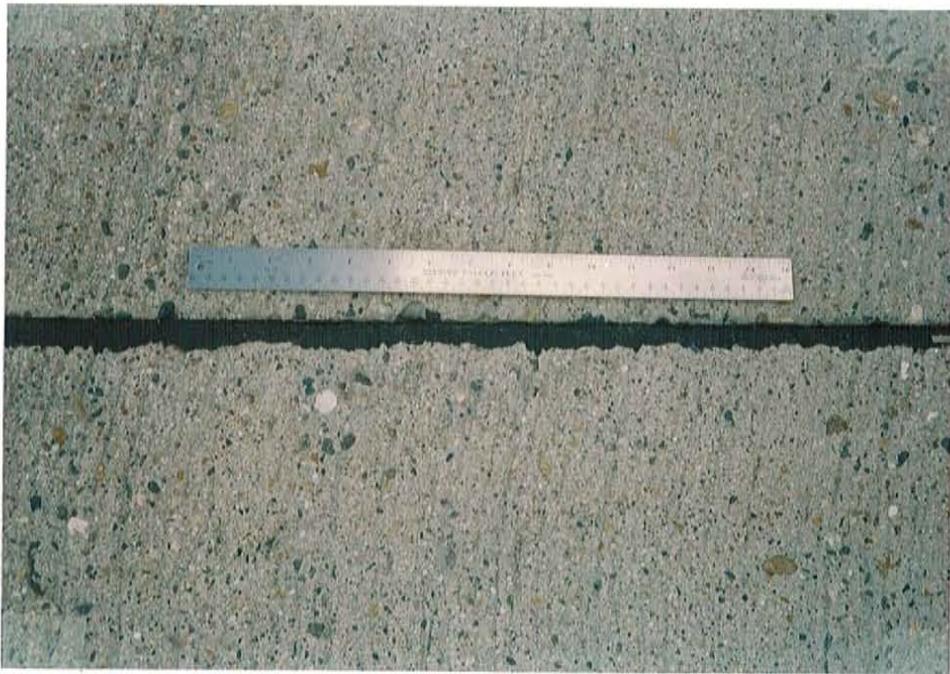
Figure 6: Typical appearance of hot pour sealant joints after eight years

depth)rate of 65 to 80 percent along the joints. Allied Koch had an average adhesive failure rate of 40 percent.

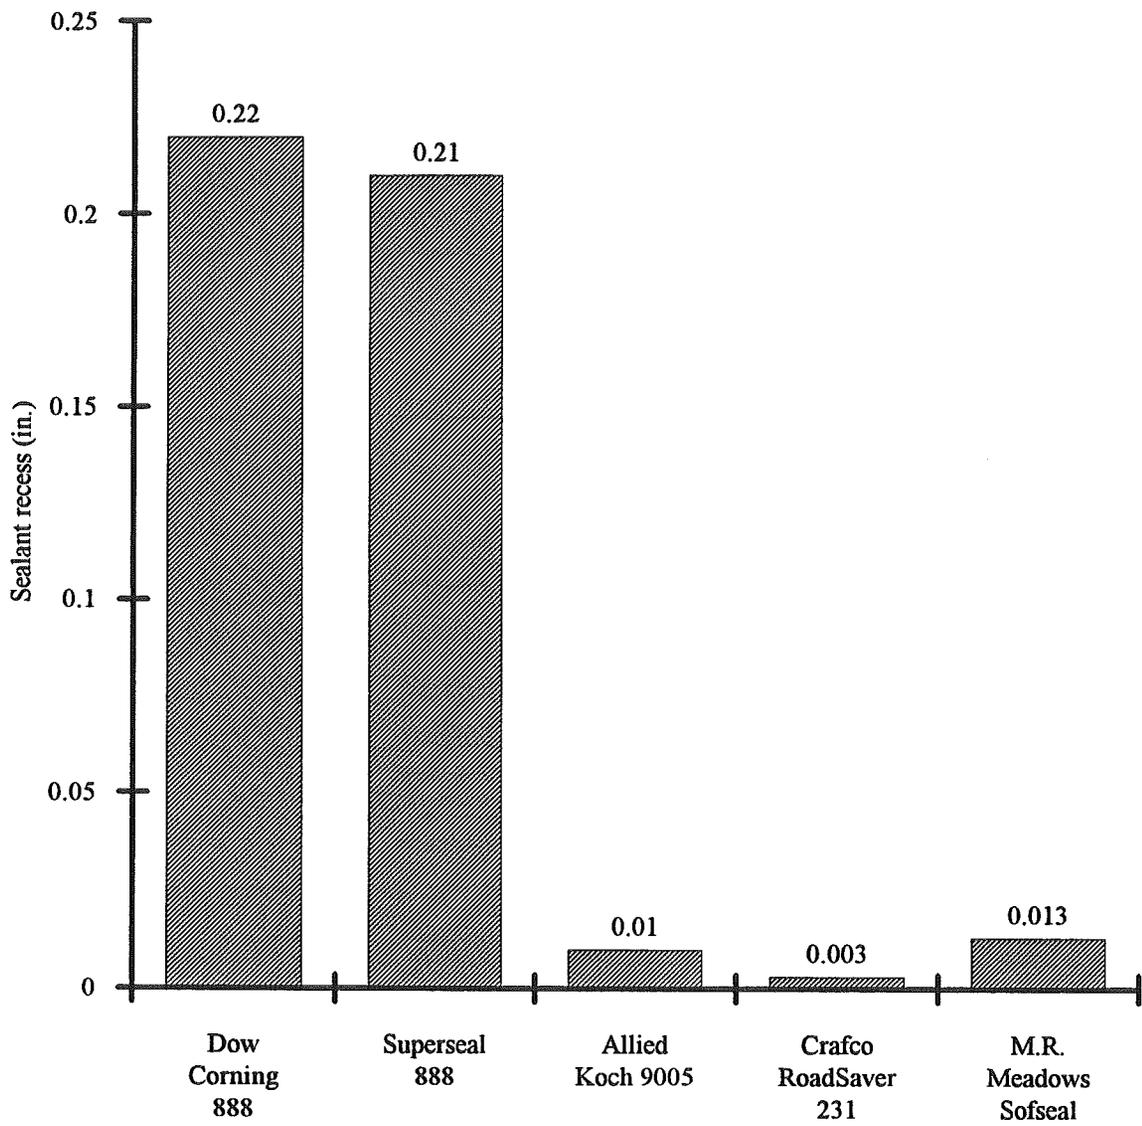
Figure 7: Average sealant recess (in inches) after eight years

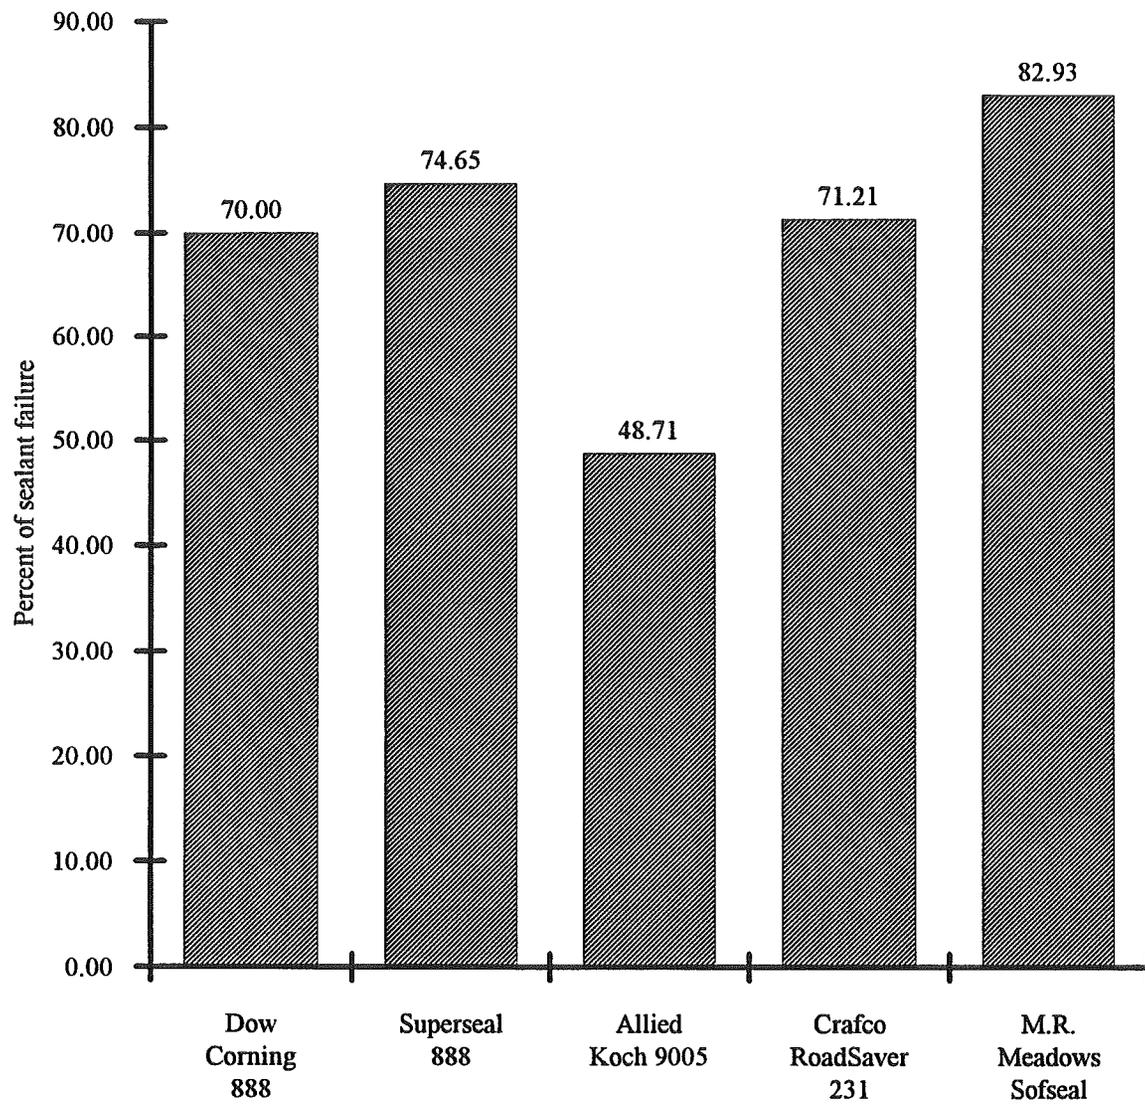
Figure 8: Percent of total sealant failure along joints

4. Dow Corning 888, Superseal 888, Crafcro Roadsaver and Meadow Soft-seal each experienced an average cohesive failure (partial and full depth) rate of less than five percent along the joints. Allied Koch had an average cohesive failure rate of 8.5 percent.
5. The average joint spalling was about 0.015 - 0.025 square feet for joints sealed with Dow Corning 888, Superseal 888, M. R. Meadows Sof-Seal; and approximately none for joints sealed with Allied Koch 9005 and Crafcro Roadsaver 231.
6. Each of the silicones recessed an average of about 0.2 in. There was no significant recess for the asphalt based hot pour sealants.
7. Approximately 40 -- 60 percent of the Superseal 444 was missing from the joints in the surveyed half-mile roadway section.
8. Joint faulting at the outside edge of the travel lane was consistently higher than faulting near the centerline.

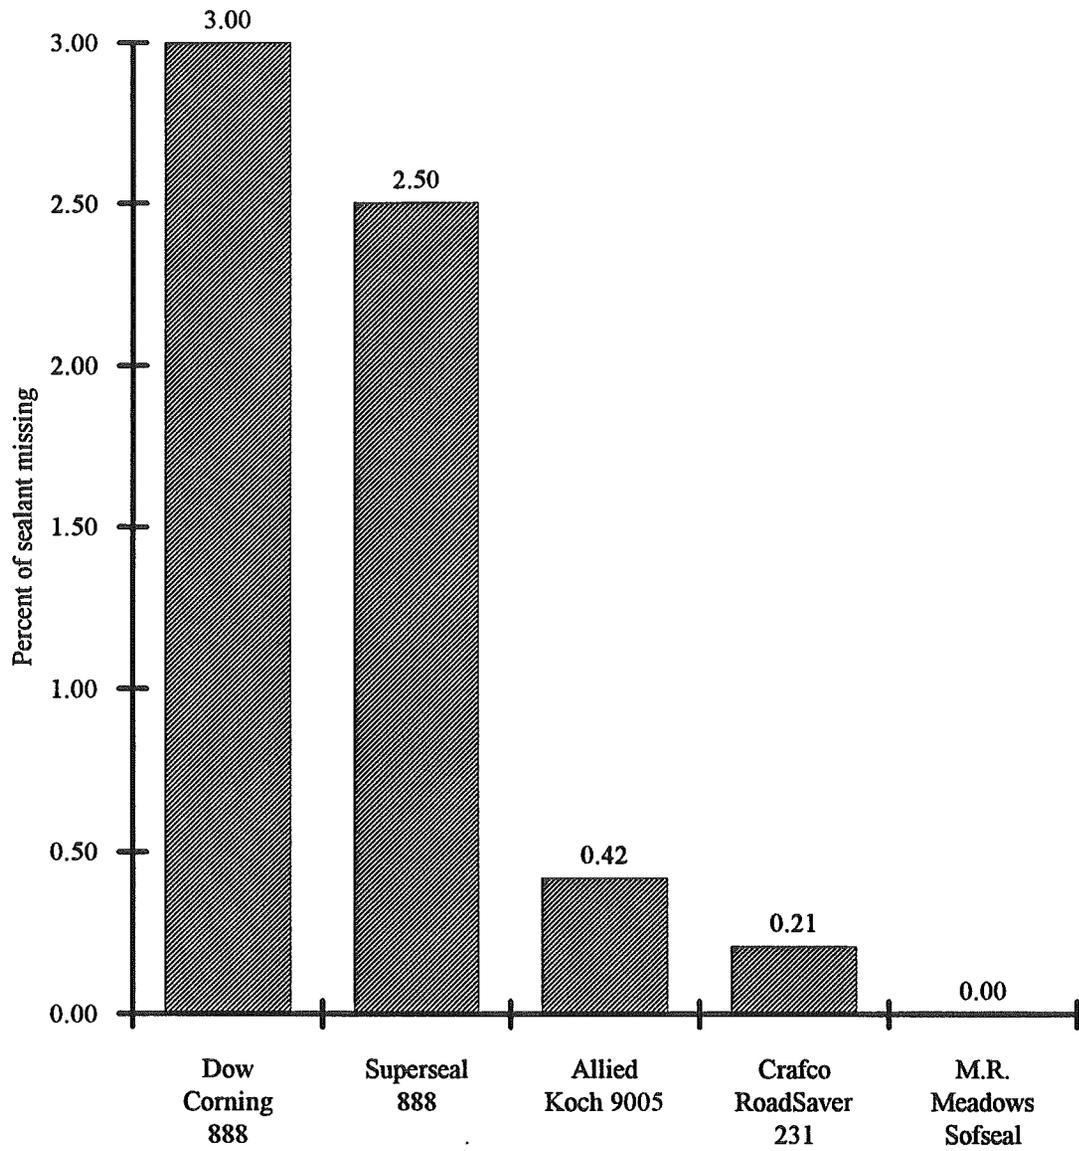
Figure 9: Percent of sealant missing from joints

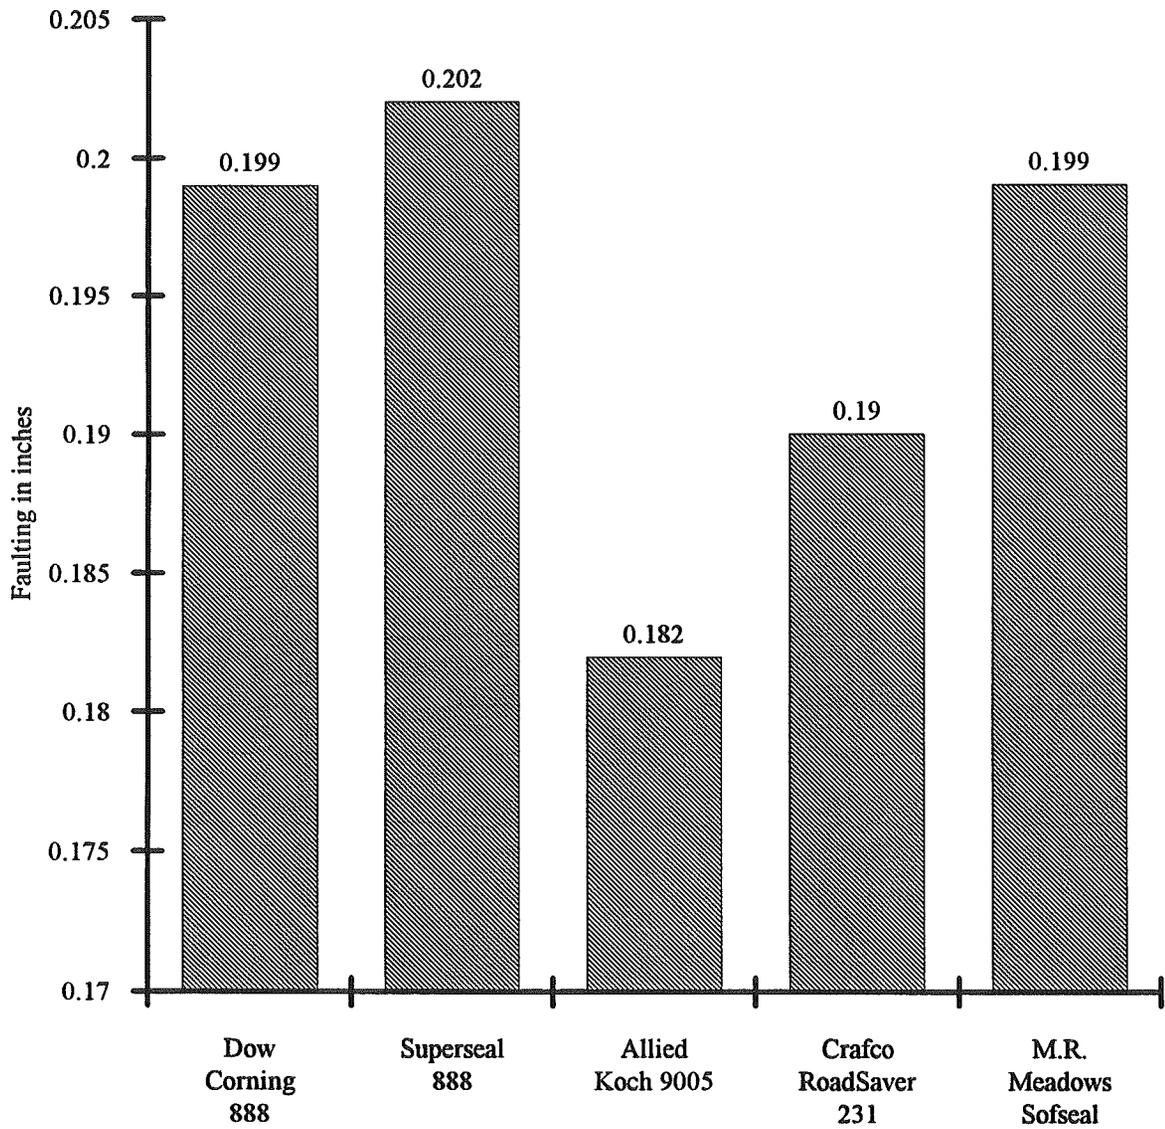
Figure 10: Average joint faulting measured near the shoulder and centerline
