*Final Report - March 4, 2002*

***Little Colorado Spinedace Habitat Survey and Restoration  
In The East Clear Creek Watershed***

**Arizona Game and Fish Department  
Heritage Fund Program IIPAM  
Grant #199006**

**Mark Whitney  
Coconino National Forest  
2323 E. Greenlaw Lane  
Flagstaff, Arizona 86004**

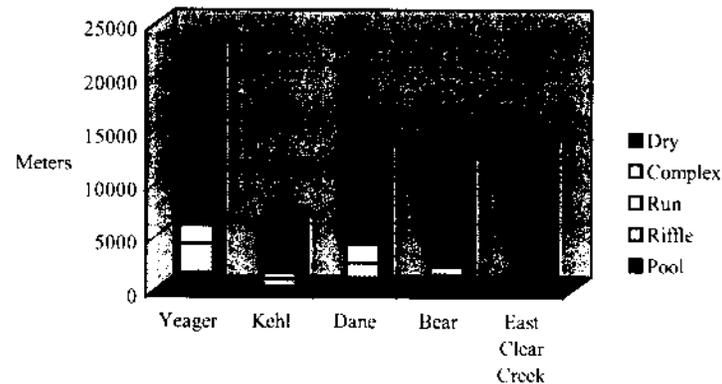
**Figure 2.** Comparisons of the sum total stream channel distance (in meters) occupied by each habitat type and dry streambed for the five inventoried stream courses.

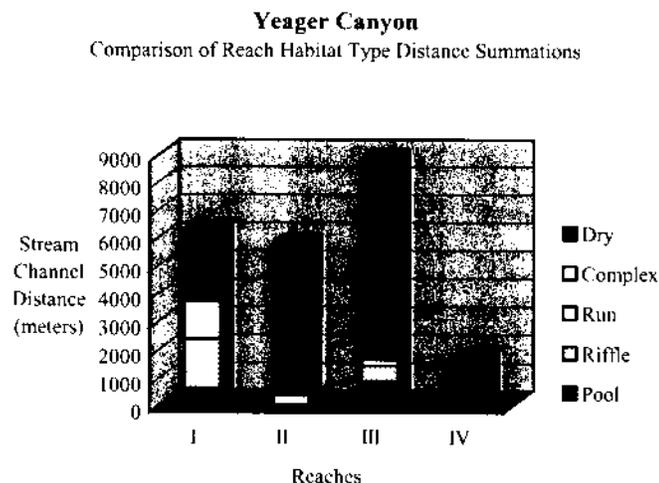
**Figure 3.** Comparisons of the sum total stream channel distance (in meters) occupied by each habitat type and dry streambed for the four reaches identified in Yeager Canyon.

Figure 3 illustrates the combined distances for each habitat type and dry stream channel found in each of Yeager Canyon’s four reaches. Given the scale used in Figure 3, pool and riffle habitat distances within Reach IV are so minimal that the representative bars for their numbers are not visible. Appendix C displays reach summations for total distance, and for the sum total distance of each habitat type. Appendix C also shows the estimated wetted surface areas and calculated 95% confidence intervals for each reach.

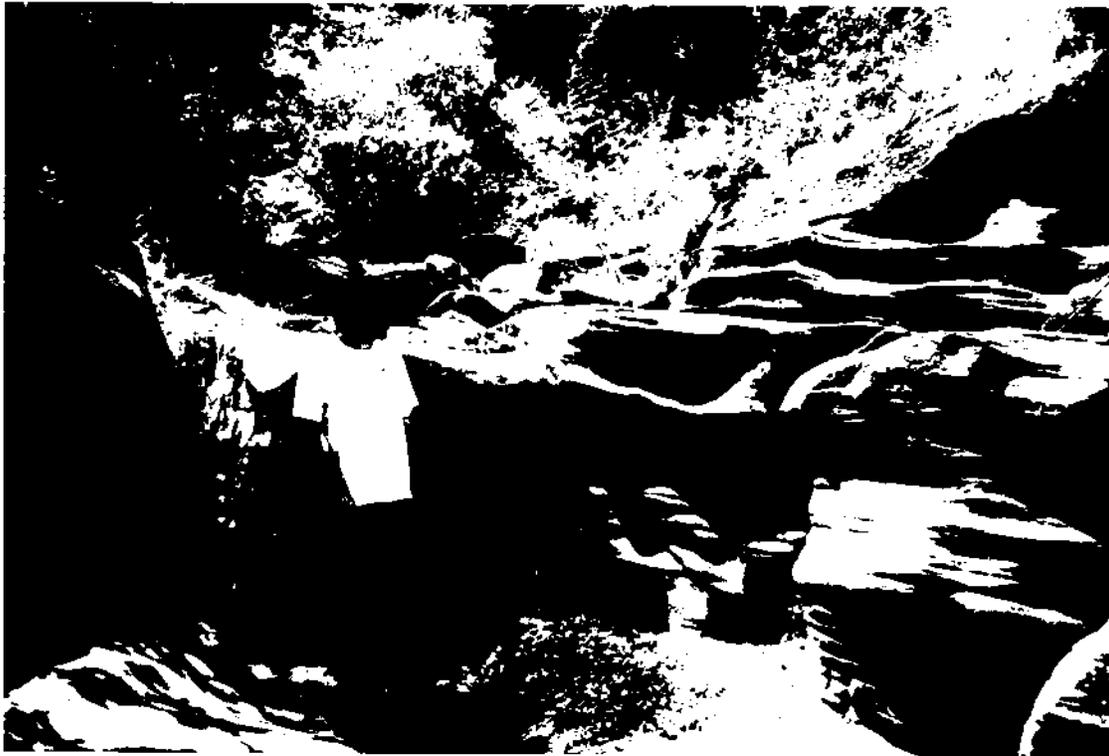
**Photo 3.** The second of three bedrock “barriers” is found at the 1,844-metered distance along the first reach in Yeager Canyon. This “barrier” measured 1.5 meters in height. Brian Clark provides scale to this instream feature located at GPS coordinates of N34° 33' 13" / W111° 08' 15”.

channel. Interspersed within this dry stretch were several isolated small pools ranging in size from .9 m long by 1.1m wide to 5.7 m long by .9 m wide. Two large woody debris dams exist at the 773 m and 1,894 m distance. The first debris pile measured eight (8) meters in length by seven (7) meters wide, while the second measured eight (8) meters long with a ten-meter width. These debris dams are composed of Class 2 and 6 sized logs. Three bedrock shelves, spanning the width of the stream channel, were encounter along a 190-meter stream channel distance. The first shelf measured 1.2 meters in height at the 1,744-metered channel distance; the second is 1.5 meters high at the 1,844-meter distance (Photo 3), and the third is nine-tenths (.9) meter in height at the 1,933-metered distance. A latitude / longitude coordinate (uncorrected) of N34° 33' 13" / W111° 08' 15" was taken at the second bedrock shelf. The first two shelves may provide an effective barrier to upstream movement of fish from East Clear Creek. The wetted portions of this reach began upstream of the 1,894 metered debris dam (Photo 4).

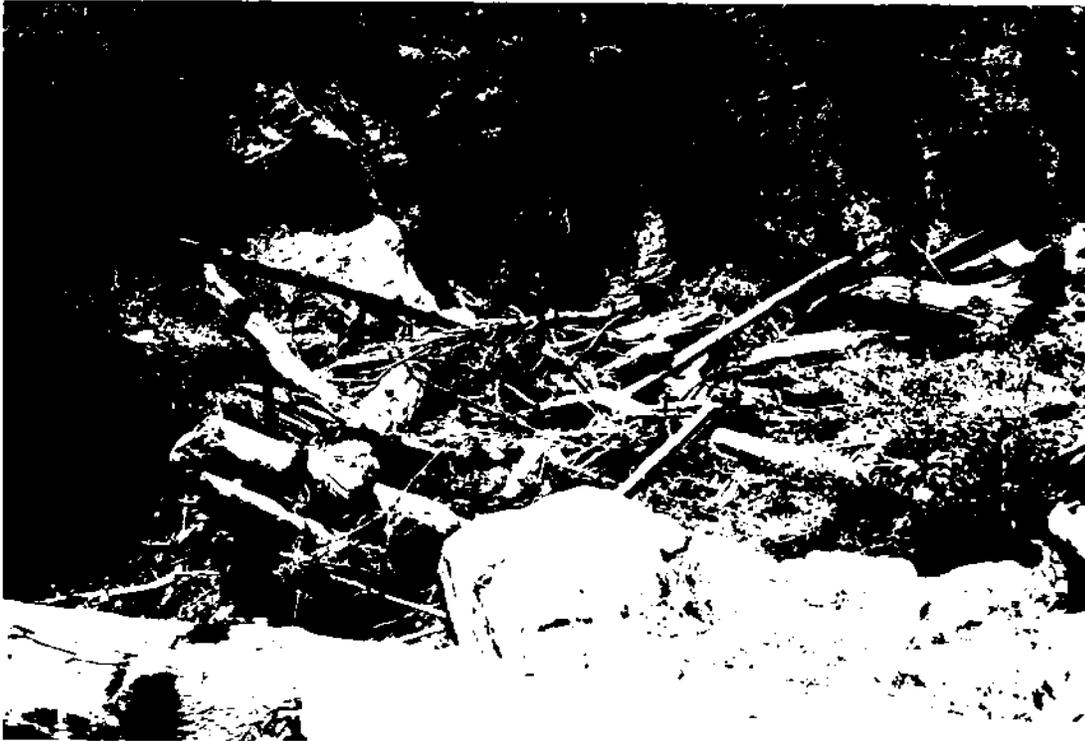
**Photo 4.** View of the upstream side of the second of two large woody debris dams within the first reach of Yeager Canyon. The one pictured above is located at the 1,894-metered distance from the ECC / Yeager Canyon confluence. This pile of woody debris spans the width of the stream channel with a width of 10 meters and covering eight (8) meters of the stream channel. The height is estimated at three (3) meters.

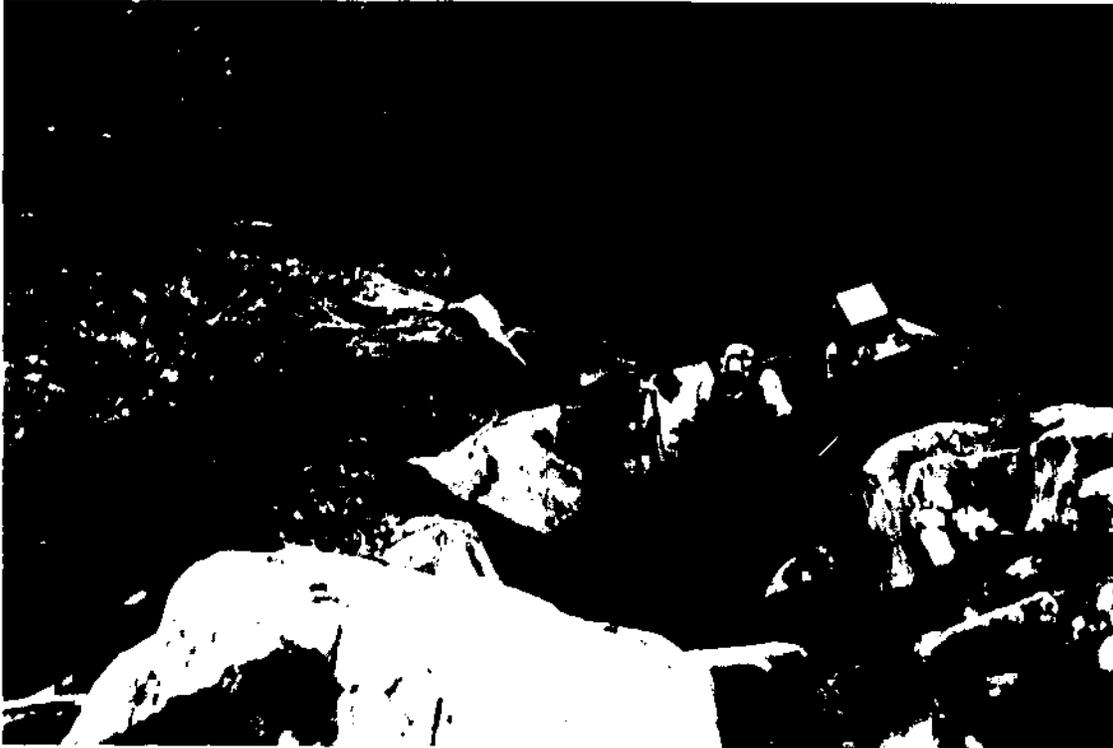
**Photo 5.** Inventory crew electrofishing Pool 41 in Yeager I on June 19, 2000. A 119-second fishing effort netted eight (8) rainbow trout ranging in size from 101 to 200 mm in 16° C water. Latitude / Longitude coordinates for Pool 41 is N34° 32.603' / W111° 07.797.

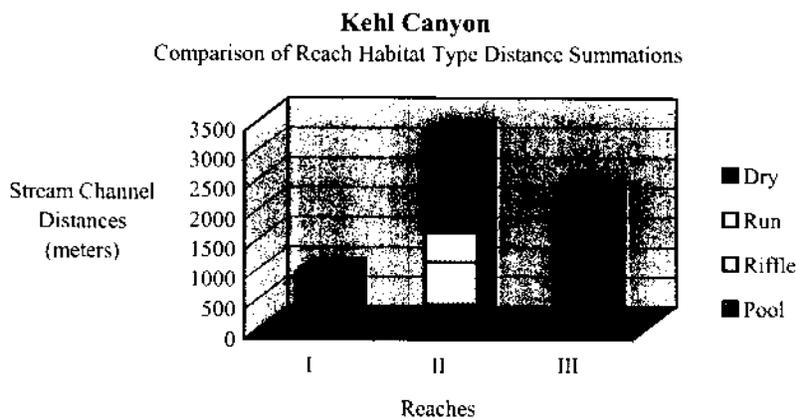
**Figure 4.** Comparisons of the sum total stream channel distance (in meters) occupied by each habitat type and dry streambed for the three reaches identified in Kehl Canyon.

Figure 4 illustrates the combined distances for each habitat type and dry stream channel found in each of Kehl Canyon's three reaches. Given the scale used in Figure 4, pool and run habitat distances within Reach I and III are so minimal that the representative bars for their numbers are not visible. Appendix C displays reach summations for total distance and for the sum total distance of each habitat type. Appendix C also shows the estimated wetted surface areas and calculated 95% confidence intervals for each reach.

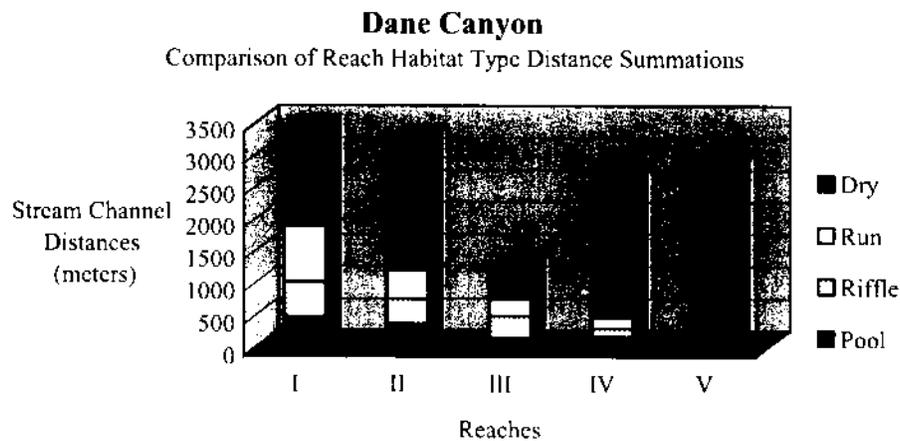
**Figure 5.** Comparisons of the sum total stream channel distance (in meters) occupied by each habitat type and dry streambed for the five reaches identified in Dane Canyon.

Figure 5 illustrates the combined distances for each habitat type and dry stream channel found in each of Dane Canyon's five reaches. Given the scale used in Figure 5, pool, riffle, and run habitat distances within Reach V are so minimal that the representative bars for their numbers are not visible. Appendix C displays reach summations for total distance and for the sum total distance of each habitat type. Appendix C also shows the estimated wetted surface areas and calculated 95% confidence intervals for each reach.

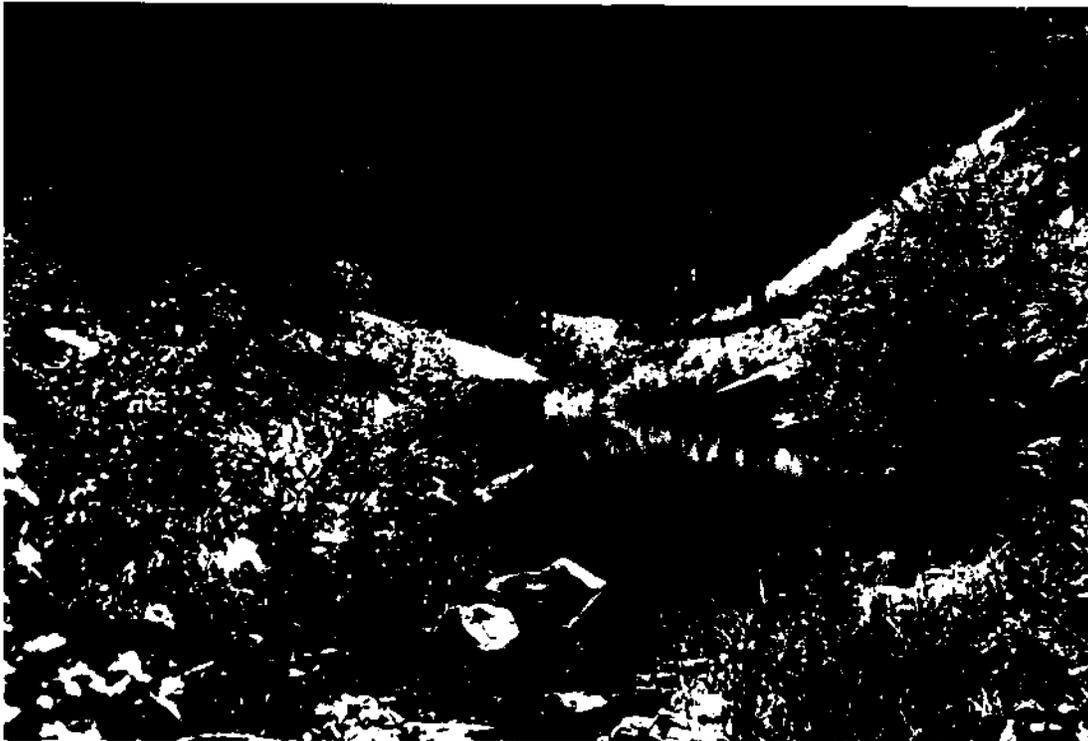
**Photo 7.** Pool 5 in Dane III on July 6, 2000. This pool measured 41 meters in length, had an average width of 5.8 meters, and had a maximum depth of greater than a meter. Substrates were comprised of silt, gravels, and cobbles. Electrofishing of Pool 5 on July 19, 2000 for 827 seconds netted 239 total fish. Fish species included speckled dace, bluehead suckers, and rainbow trout. Water temperature was 22° C.

Dane III extends from its confluence with an unnamed tributary, which receives a flow from Dane Spring upstream to its confluence with McClintock Draw. Pool 5 (378 metered distance) had a depth greater than one meter (Photo 7). Spring flow at the 605 metered distance contributes enough flow to the upstream end of Riffle 12 to maintain a sustained flow for a distance downstream. There was no stream flow upstream of where the spring entered the stream channel.

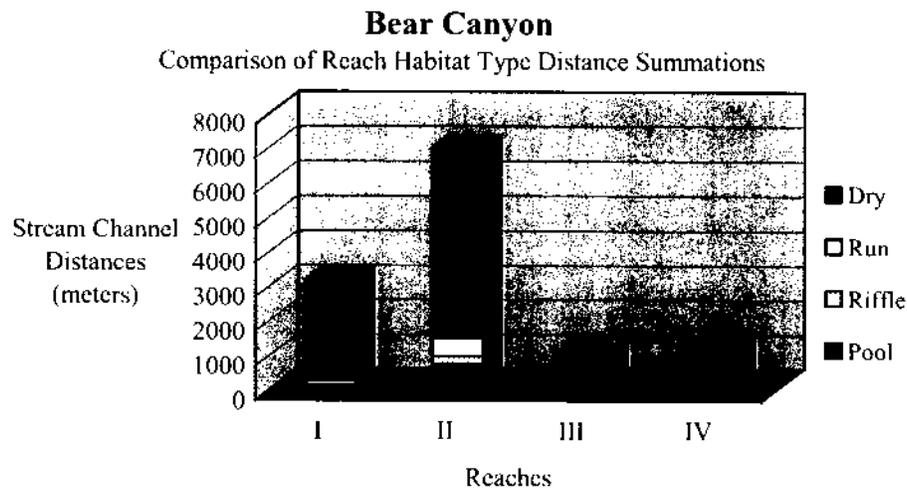
**Figure 6.** Comparisons of the sum total stream channel distance (in meters) occupied by each habitat type and dry streambed for the four reaches identified in Bear Canyon.

Figure 6 illustrates the combined distances for each habitat type and dry stream channel found in each of Bear Canyon's four reaches. Given the scale used in Figure 6, pool, riffle, and run habitat distances within Reach III and IV are so minimal that the representative bars for their numbers are not visible. Appendix C displays reach summations for total distance and for the sum total distance of each habitat type. Appendix C also shows the estimated wetted surface areas and calculated 95% confidence intervals for each reach.

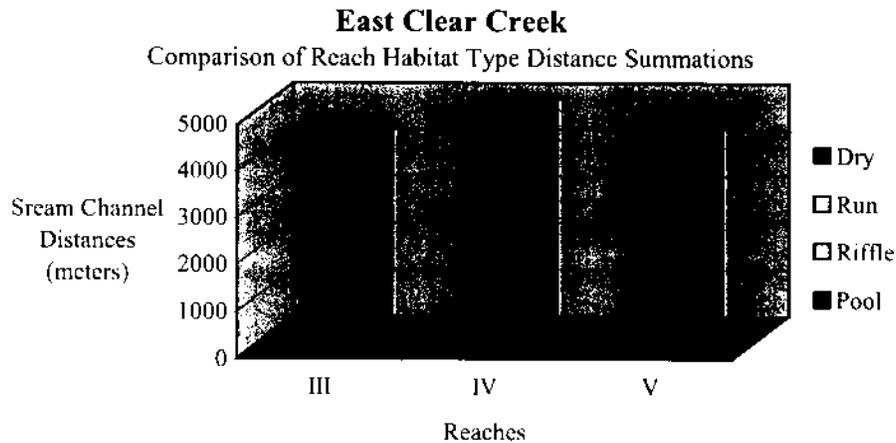
**Figure 7.** Comparisons of the sum total stream channel distance (in meters) occupied by each habitat type and dry streambed for the three reaches identified in East Clear Creek.

Figure 7 illustrates the combined distances for each habitat type and dry stream channel found in each of the three inventoried reaches. Given the scale used in Figure 7, all pool, riffle, and run habitat distances within all three reaches are so minimal that the representative bars for their numbers are not very visible. Appendix C displays reach summations for total distance and for the sum total distance of each habitat type. Appendix C also shows the estimated wetted surface areas and calculated 95% confidence intervals for each reach.
