**ARIZONA  
TRANSPORTATION  
RESEARCH  
CENTER**

# **RUSCOE 983 JOINT SEALANT**

PRODUCT EVALUATION

84-10

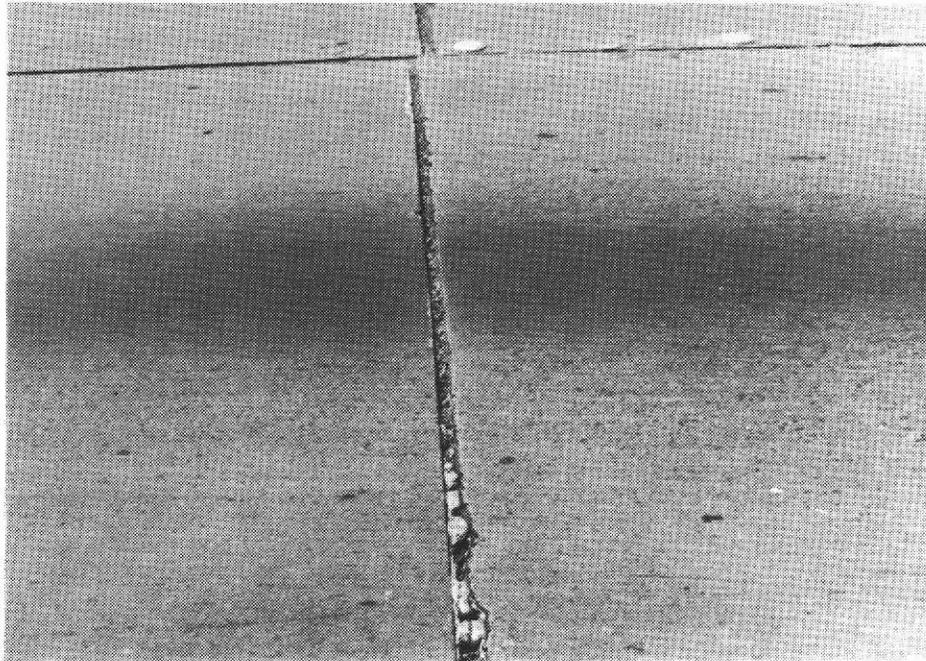
FIGURE 5 - POORLY PERFORMING JOINT SEALER

A third evaluation was made on June 20, 1985. The material in the asphalt cracks had been torn in a number of places from

the traffic. The concrete-asphalt joint was also not holding up well. There was no adhesion between the concrete and the sealant. The concrete joints on the mainline were in poor shape. Portions of the sealant had been completely torn out.

A final evaluation on April 7, 1986, confirmed that all three types of applications were performing poorly (Figure 5).

The Arizona Transportation Research Center recommends not using Ruscoe 983 as a joint sealant or crack filler due to its poor performance in the above mentioned field tests. The sealant did not hold up well under traffic and exhibited poor bonding capabilities. No further evaluation will be performed on this product.
