ARIZONA DEPARTMENT OF TRANSPORTATION

REPORT NUMBER: FHWA-AZ--8801

# PAVING FABRICS FOR REDUCING REFLECTIVE CRACKING

## Final Report

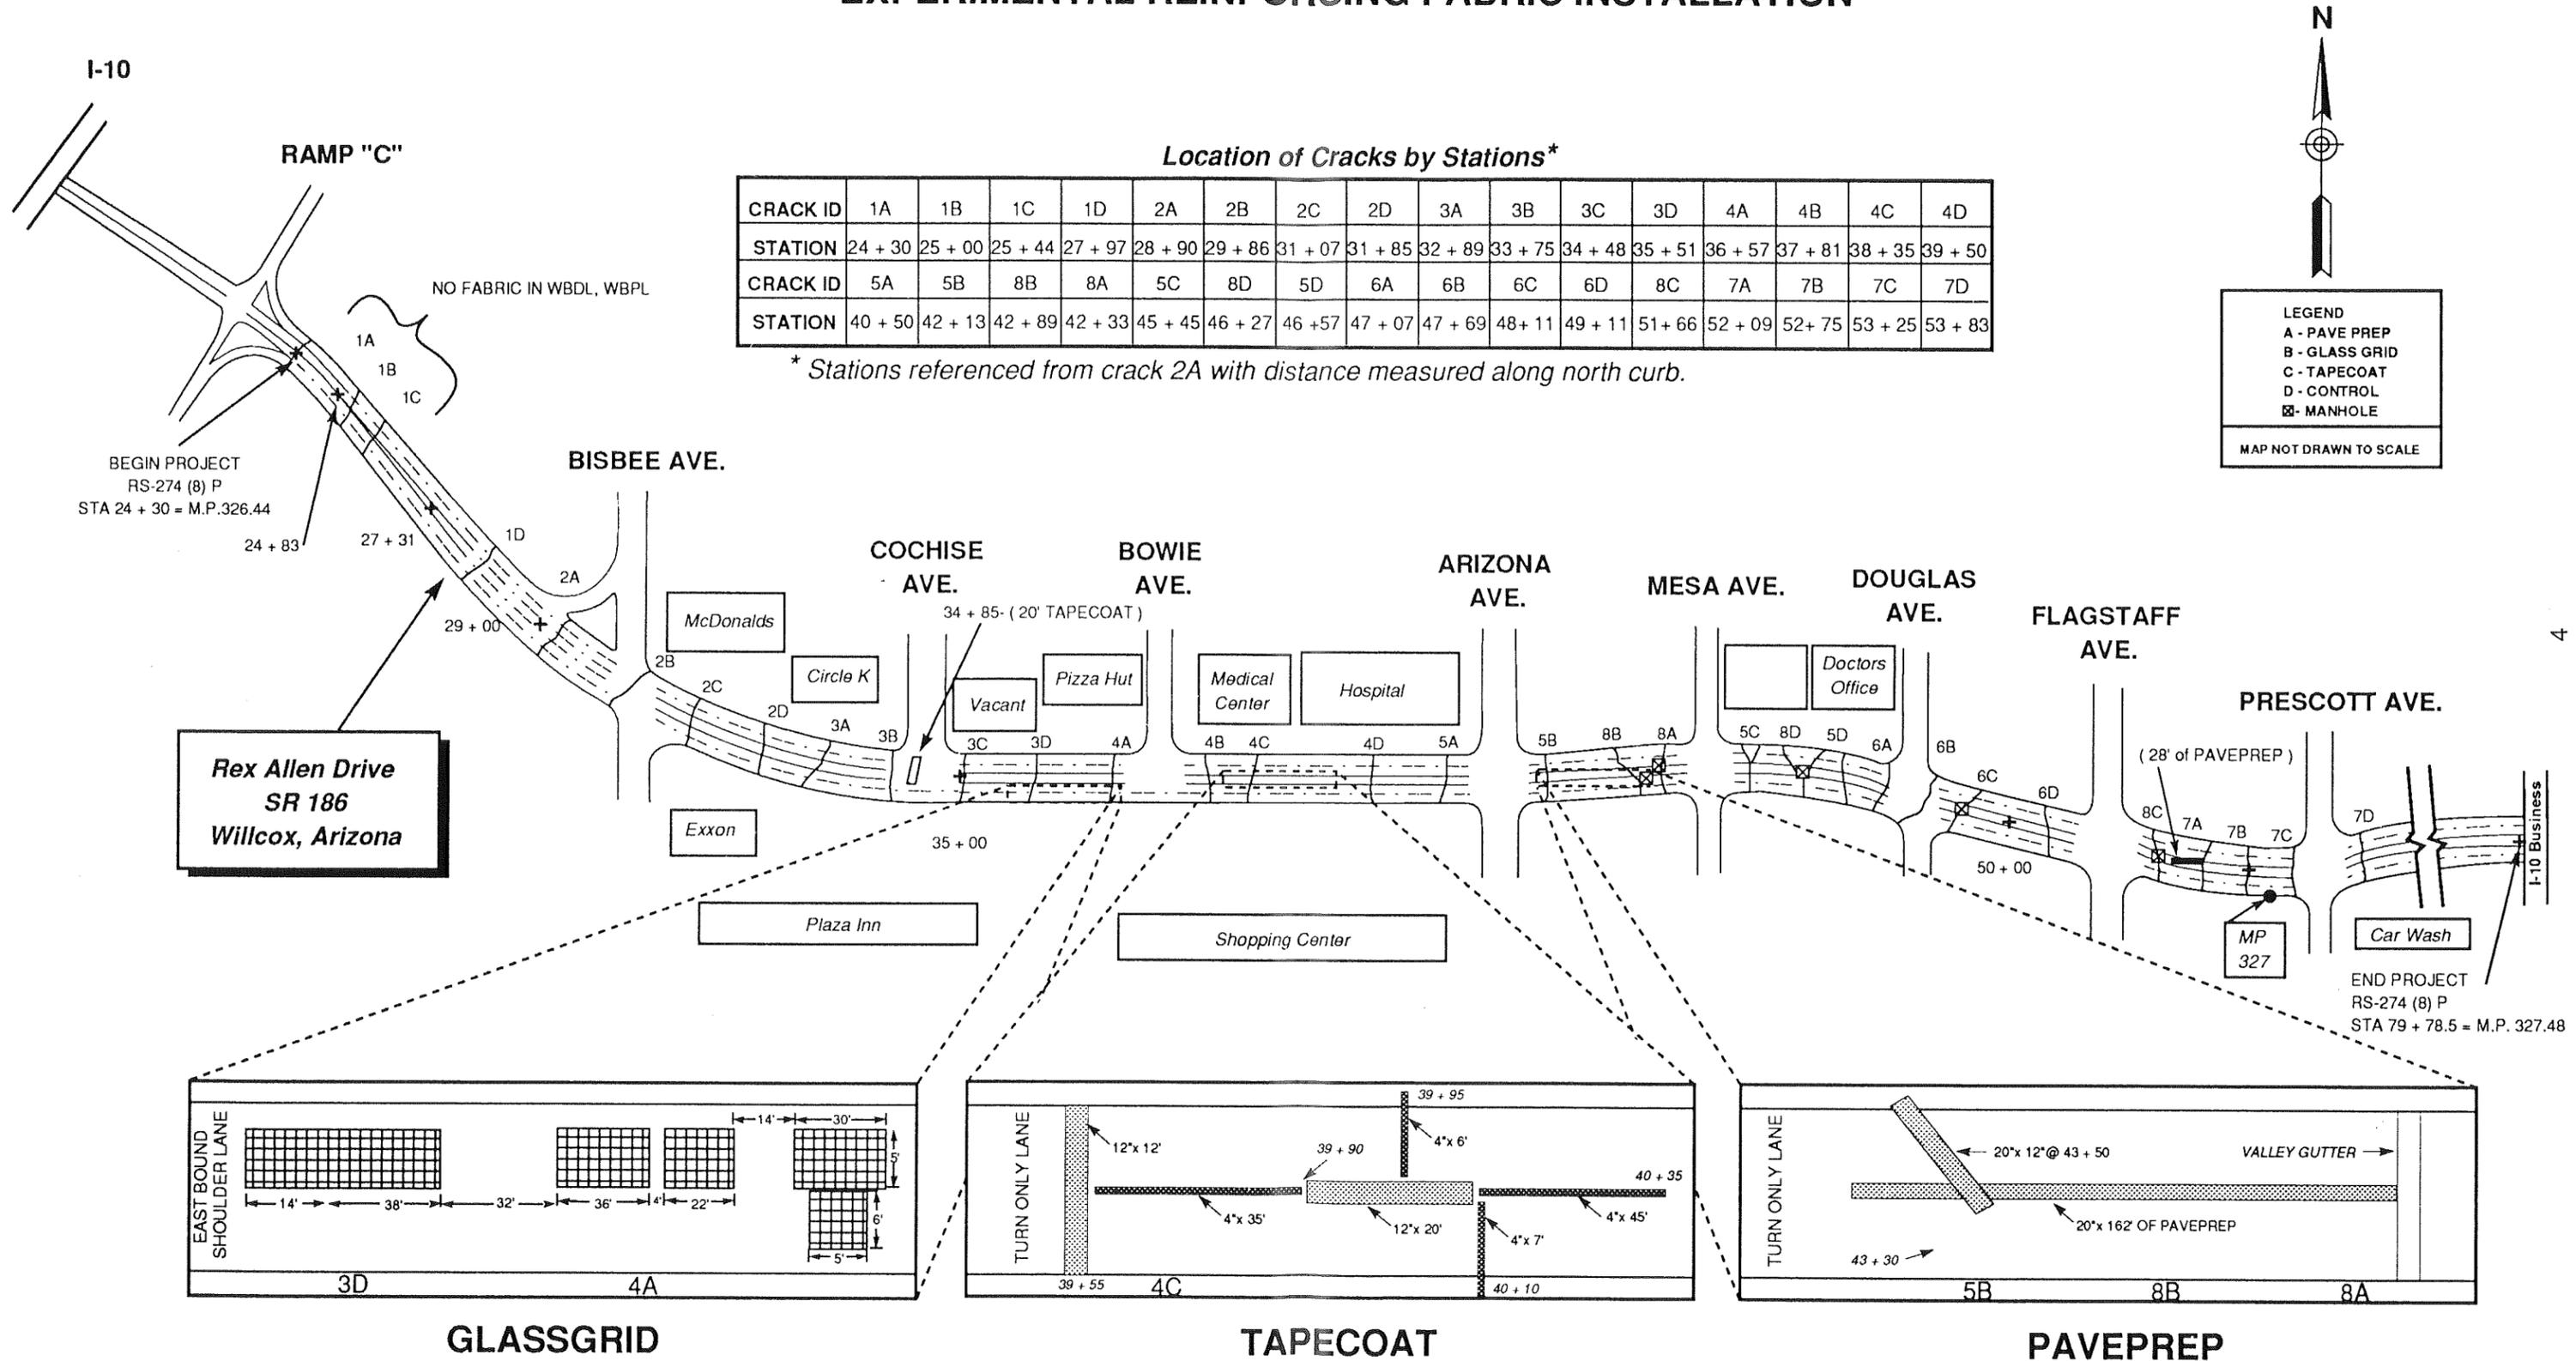
Figure 3 The Test Section.

Figure 3 is an illustration of the test section portion of the construction project where the three paving fabrics were placed on transverse cracks prior to overlay placement. The stations designated in Figure 3 are based on distances measured along the curb of the north side of the street from the reference station 24+30. Station 24+30 was used as the reference station since surveyors had marked it on the roadway. The corresponding crack location stations are inconsistent with the actual construction plans stations for the sake of simplicity in locating and identifying the cracks at future dates.

On the first day of paving (Aug. 8), the three transverse cracks identified as 1A, 1B, and 1C were overlaid without paving fabric on the westbound driving and passing lanes. This has been noted in Figure 3.

Observations were made in the random and longitudinal crack treatment areas. The 28 ft. long longitudinal crack treated with Paveprep (refer to Figure 3) showed no sign of reflective cracking. The other Paveprep treated random cracking area between Arizona Ave. and Mesa Ave. was not evaluated. The Tapecoat treated area between Bowie Ave. and Arizona Ave. showed approximately 32 ft. out of a potential 216 ft. reflective cracking. The Glassgrid treated area between Cochise Ave. and Bowie Ave. showed no apparent reflective cracking.

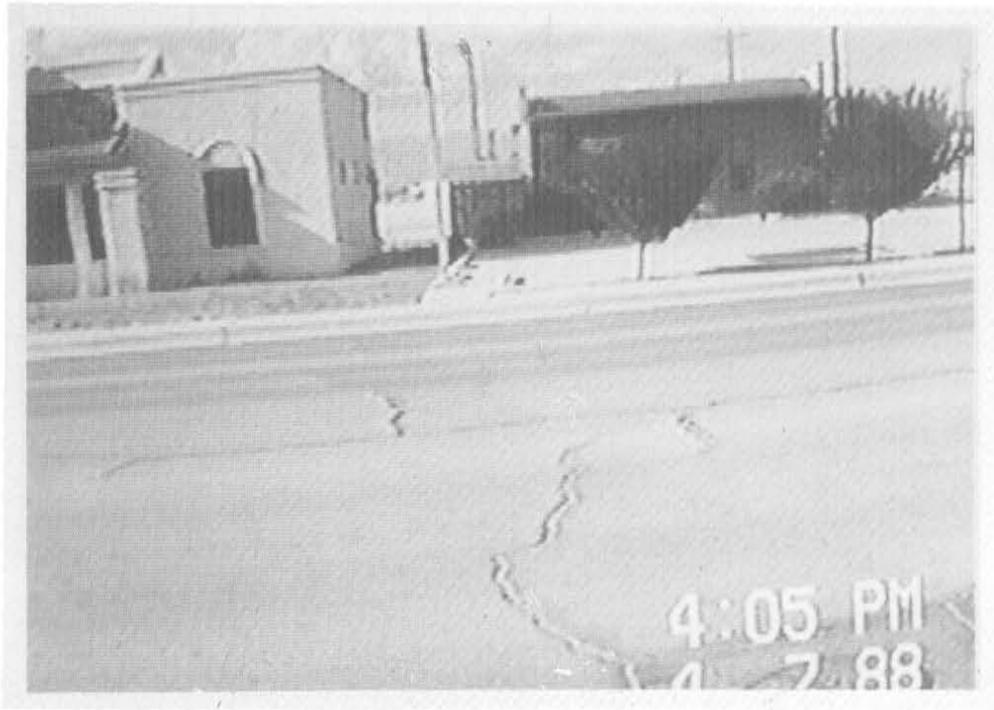
**Figure 5** Typical Transverse Crack in the Pavement.

Figure 5 shows a typical transverse crack in the pavement. Most of the transverse cracks had been filled with sealant, but much of the sealant had been tracked onto the pavement. The cracks had been filled with dirt and small incompressibles. The portland cement concrete curbs, gutters, and sidewalks in the vicinity were badly cracked, as shown in Figure 6. It appears as though moisture intrusion into the subgrade may have increased the severity of the cracking.

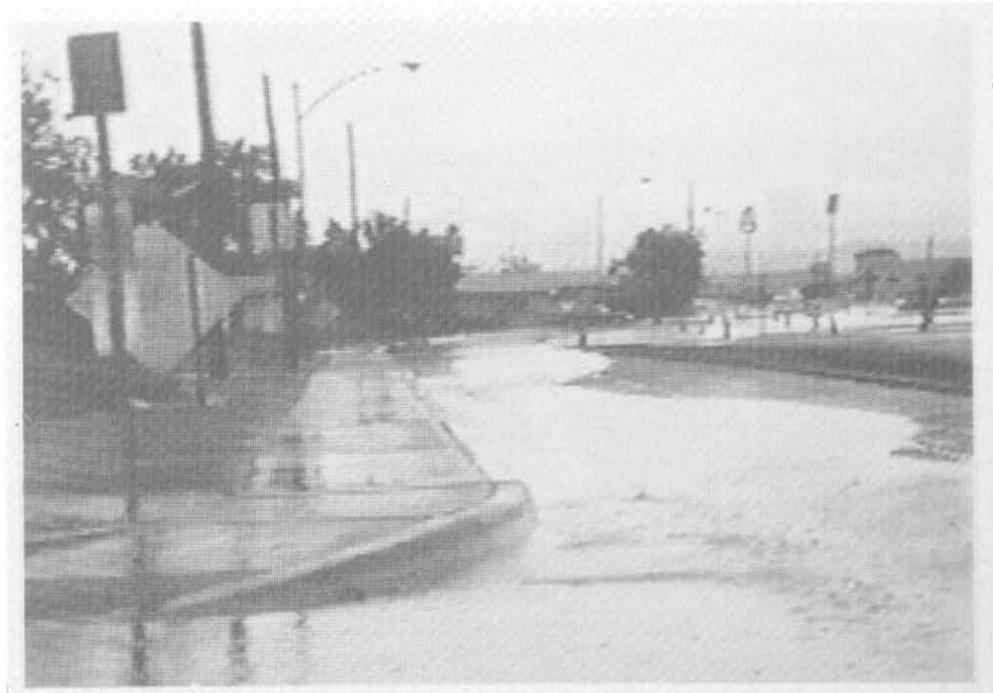
**Figure 7** Gutters Filled with Runoff.

Drainage on the road was a problem, and still is. There is no provision for removing rain water from the street. As such, the water tends to settle along the curbs and gutters, migrating through cracks and joints into the base and subgrade. Figure 7 illustrates the drainage problem. Subgrade samples taken during the initial construction were determined to have a water content of 30.7 percent.

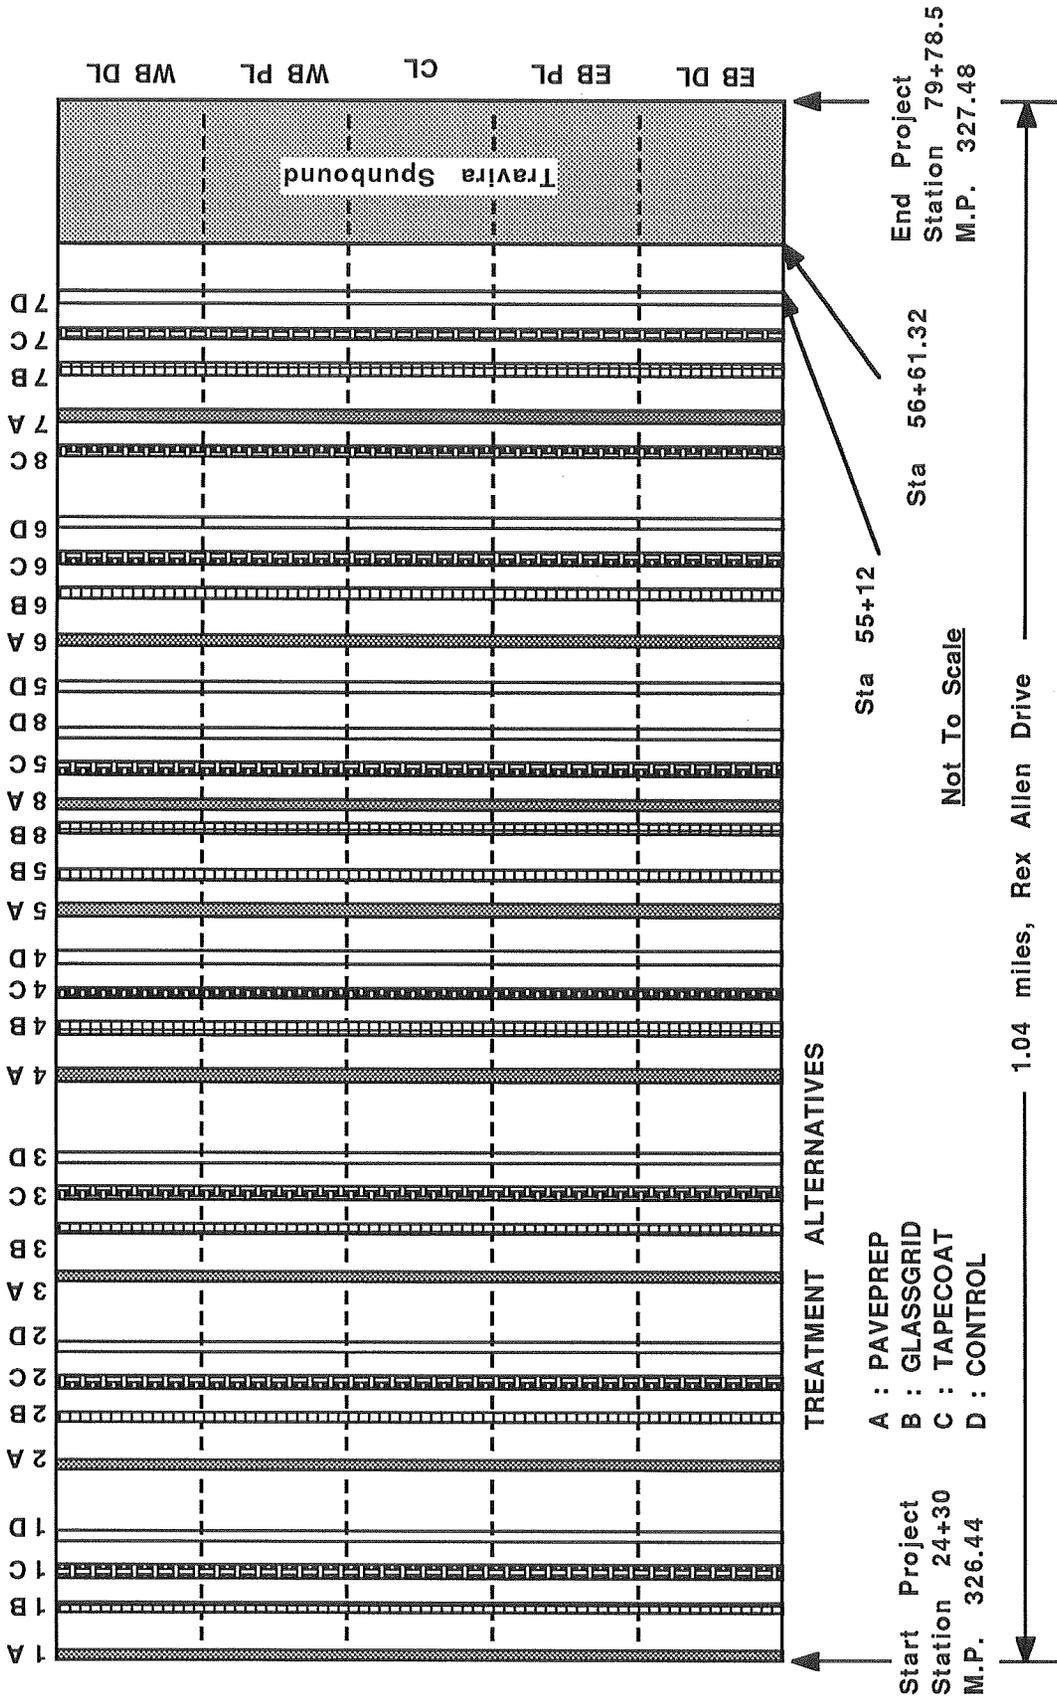
Figure 8 Experimental Design.

With the objective of evaluating the three paving fabrics' field performance at reducing reflective cracking on Arizona's highway pavements, an experiment was formulated to compare the three fabrics with each other and with the "do nothing" alternative. The experiment consisted of treating 32 high severity transverse cracks with the 4 treatment alternatives; Paveprep, Tapecoat, Glassgrid, and "do nothing". The "do nothing" treatment will also be referred to as the control, or the control treatment, in this report.

Eight replicates of each alternative were selected based on the number of full-width transverse cracks available. The eight replicates were spread over 8 different randomly determined locations in the test site, providing a statistical design that blocks the effect of location variability. Figure 8 shows the conceptual design of the experiment. The locations of the test cracks were marked with washers set in epoxy on the nearby curb to facilitate future monitoring and evaluation.

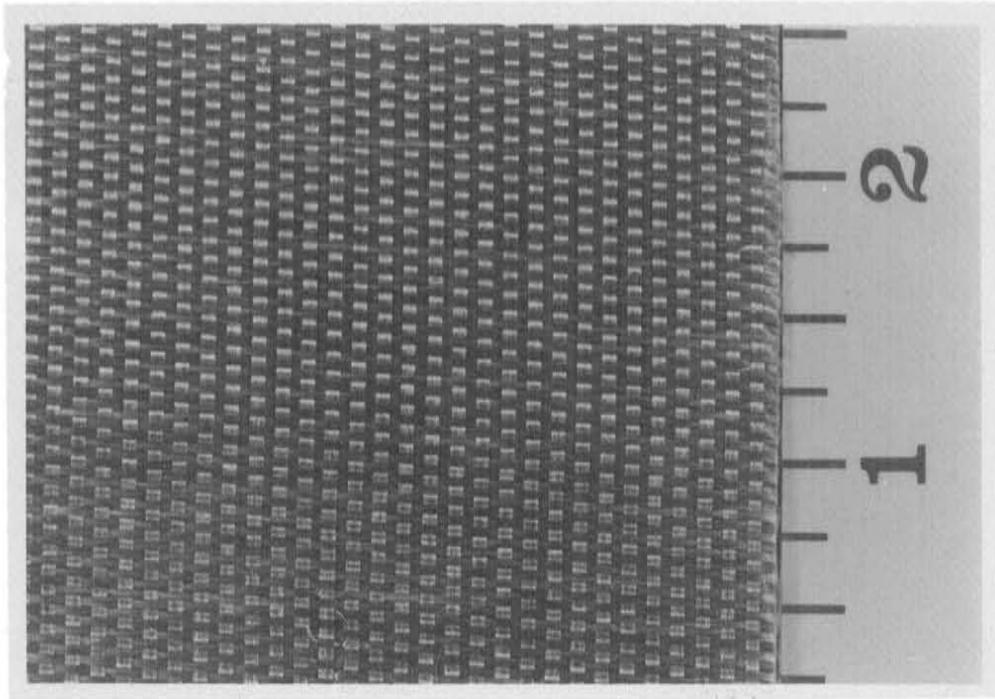
**Figure 9** Paveprep Paving Fabric.

Paveprep is a high density polymerized asphalt mastic sandwiched between two layers of polyester fabric. Figure 9 is a photograph of the material with a tape measure labeled every 1 inch. The product is manufactured by International Coating Systems, Inc. and has previously been known as Prepave and Pre-Pave. Paveprep is 120 mils thick and is available in rolls of 12 to 42 inches. The product requires the application of an asphalt cement to bind it to the existing surface. The free-on-board cost of Paveprep is \$9.00 per square yard. Five 20-in. wide rolls, each 102 ft. long, were used for the experimental project and were supplied free of cost by the manufacturer.

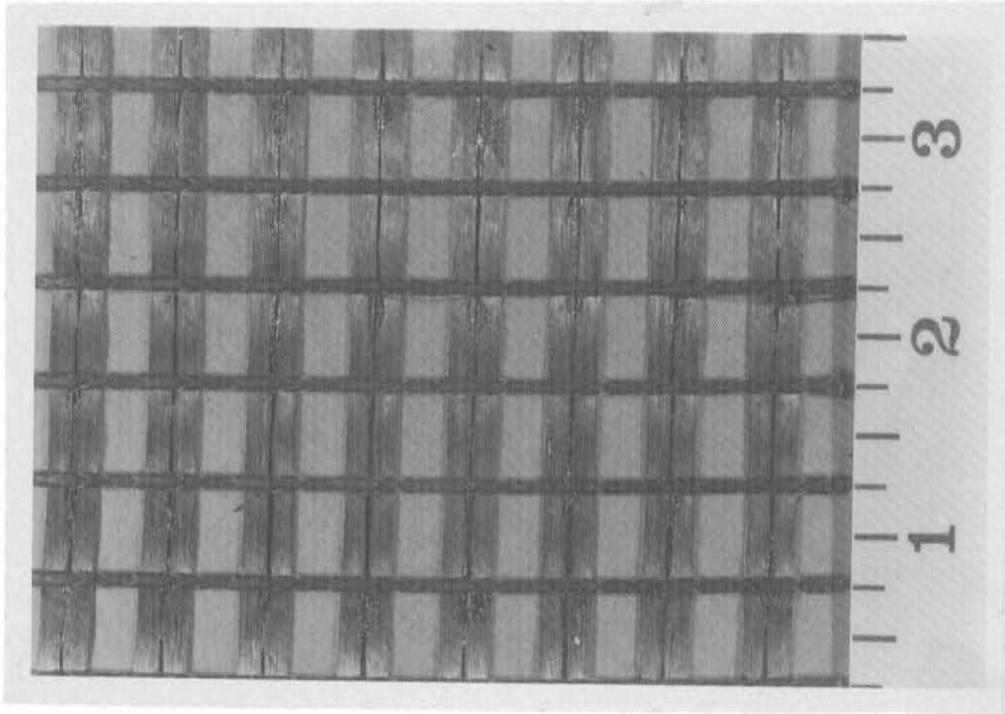
Figure 10 Glassgrid Paving Fabric.

Glassgrid is a paving fabric composed of glass fibers bundled into strands which are held in place by polyester thread. The product is manufactured by Bay Mills Limited. Figure 10 is a photograph of Glassgrid with a tape measure in inches. The product's grid structure is the result of weaving the glass fiber strands together. Glassgrid comes in two different categories; the "detail repair", and "complete road" systems. The detail system has double strands and as such has a higher tensile strength and weight than the single strand complete system. For the Rex Allen Drive project, the detail system of Glassgrid was used. At the time of construction Glassgrid cost \$2.25 per square yard, but was provided free of charge by the manufacturer.

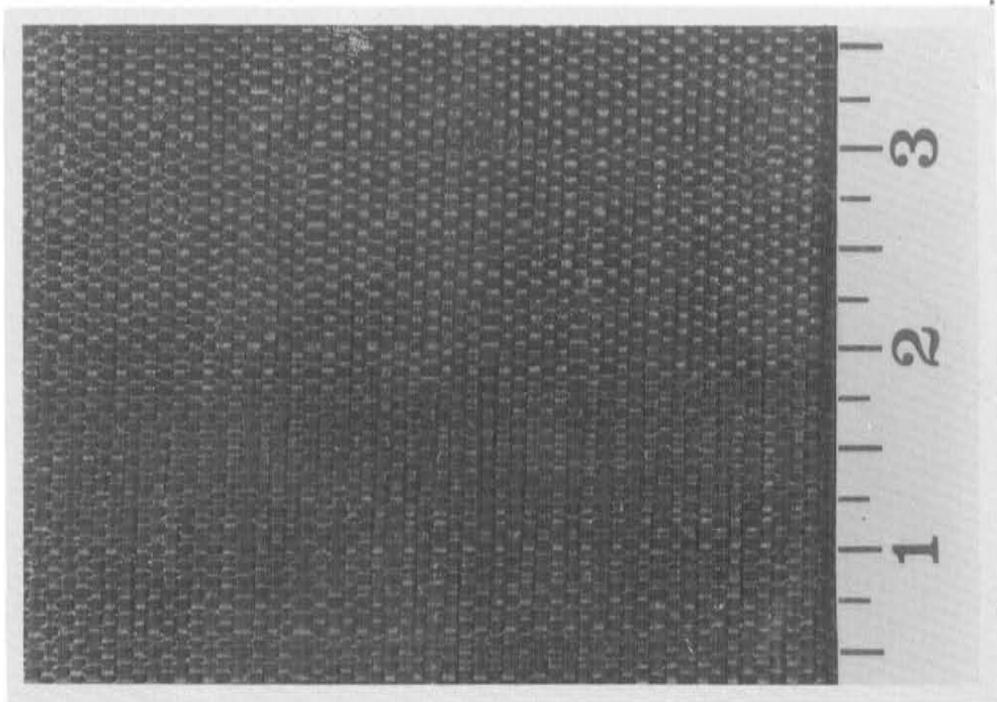
Figure 11 Tapecoat Paving Fabric.

Tapecoat M-860 is a pre-formed elastomeric resin bound with an adhesive to a woven polymer fabric. The product is cold-applied and self-adhering. Tapecoat M-860 is manufactured by The Tapecoat Company and is available in 4, 6, and 12 in. wide rolls 150 ft. long. Figure 11 depicts Tapecoat M-860 with a tape measure in inches.

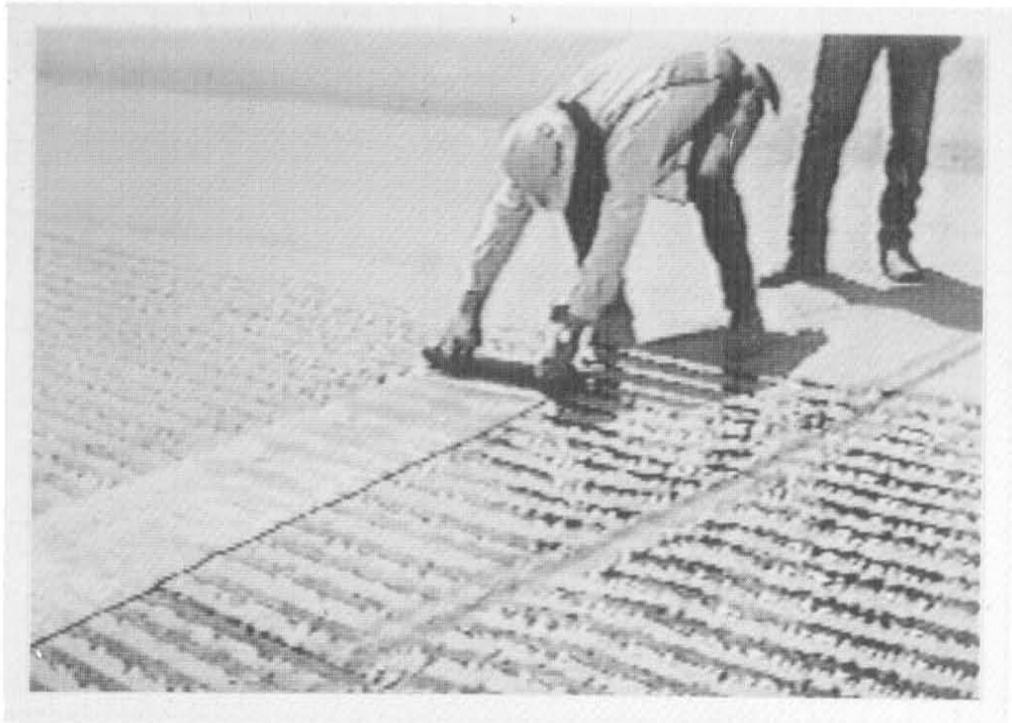
**Figure 15** Paveprep Installation on a Transverse Crack.

Eight transverse cracks, crossing 468 ft. of pavement, were treated with Paveprep. An additional 202' of random cracking was covered with the fabric. Paving was to be carried out by lane, and likewise so was the fabric treatment. The installation of Paveprep involved tacking the surface with AC-30, cutting and rolling out the fabric, and walking across it. The installation took place about 400 ft. ahead of the paving machine. Figure 15 shows a Paveprep installation.

During the placement of Paveprep there were problems with the fabric not adhering to the milled surface. Several methods were incorporated in an attempt to achieve a better bond. First, the contractor applied the binder coat for the entire overlay at the rate of 0.20 gal./sq. yd., rather than specified 0.25 to 0.30 gal./sq. yd., and then placed the Paveprep. This was not successful in creating a better bond. Next, the contractor tried to lay the fabric on an AC-30 tack, and then add the binder coat of AC-30. This strategy had limited success, however, the supplier of the AC-30 did not have a paving wand with a reinforced hose to apply the tack for the Paveprep placement. Instead, the spray nozzles on the back of the boot truck were turned on and off as the driver drove over the cracks. This led to problems with adequate coverage and proper quantities.

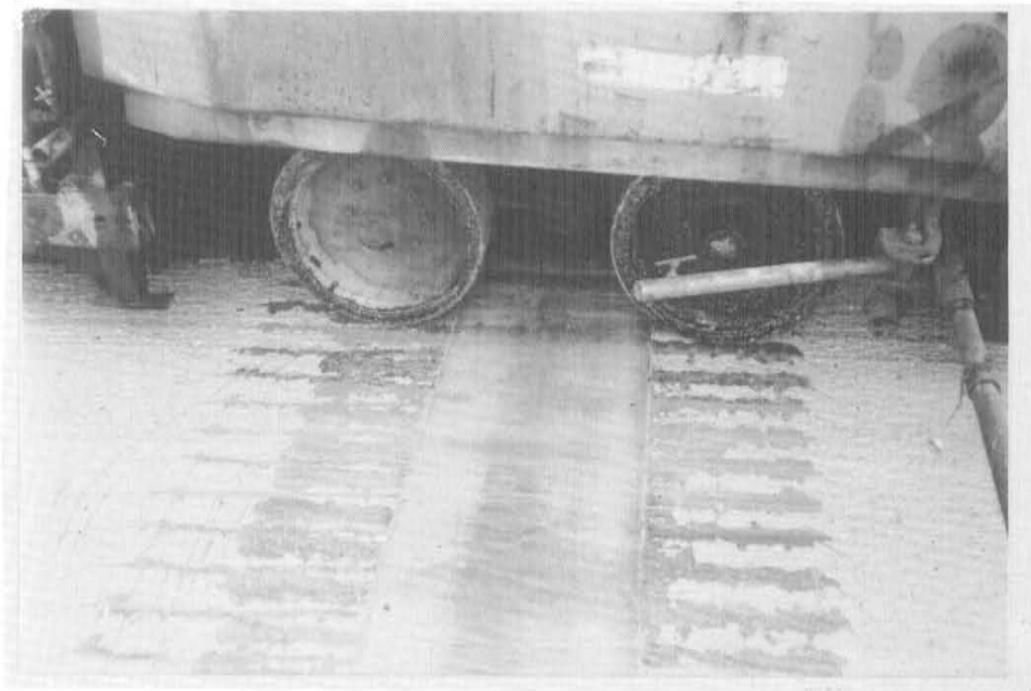
**Figure 16** Tack Accumulated on the Wheels of the Paving Machine.

During paving, the binder coat was sticking to the tires of the trucks and the laydown machine. As a result, when this equipment would cross over the paving fabric, the fabric would be pulled up by the equipment tires. Figures 16 and 17 illustrate instances where construction traffic had picked up some of the installed fabrics before placement of the overlay. Also, in some instances the fabric would tend to ball up in the overlay during compaction because of poor bonding with the existing surface.

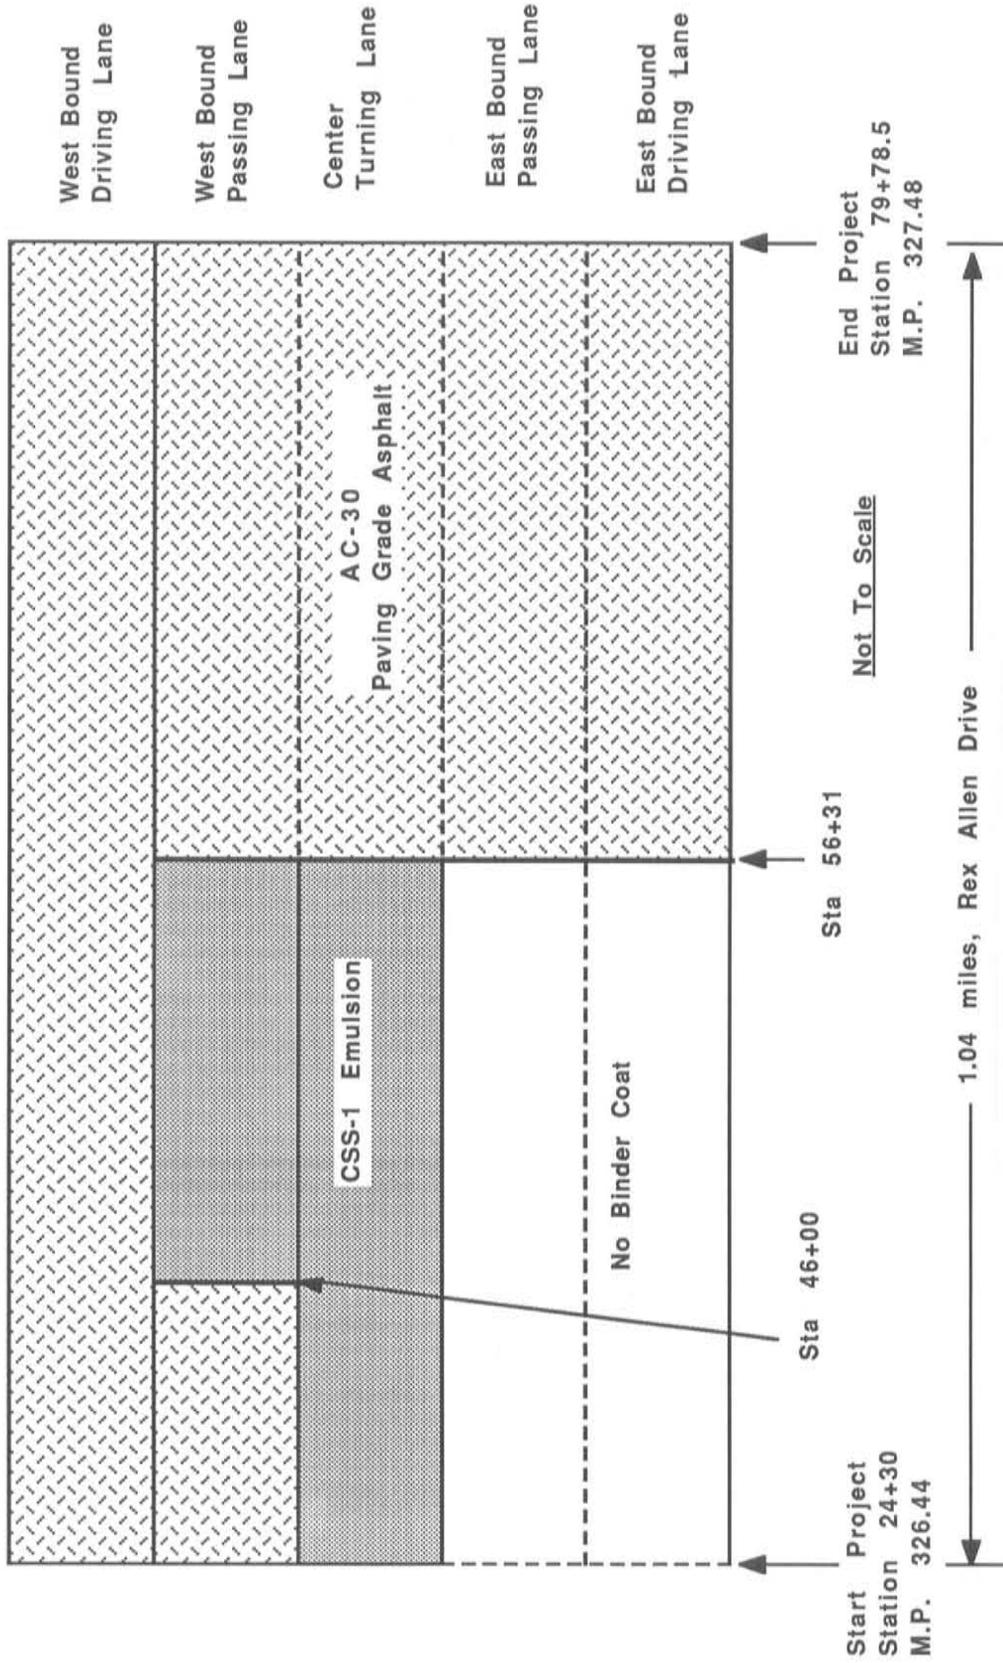
Figure 18 Location of Binder Coats.

After the first day of paving the binder coat for the overlay was changed from AC-30 to CSS-1 emulsion. CSS-1 is a cold-applied liquid emulsion. Figure 18 shows the specific locations where the two binder coats were applied. The boot truck with the AC-30 had been used for tacking the Paveprep and Spunbound. The paving fabrics did not get picked up on the tires of the construction traffic as frequently when the CSS-1 was used.

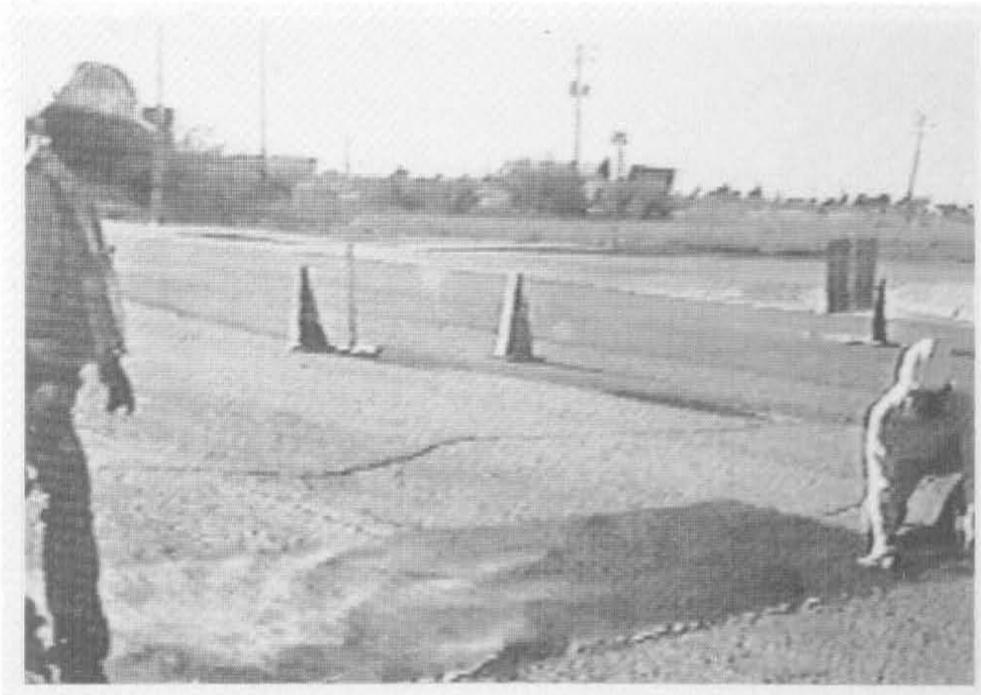
**Figure 19** Glassgrid Installed on a Transverse Crack.

Eight transverse cracks, crossing 470 ft. of roadway, and 146 ft. of random cracking were treated with Glassgrid. Glassgrid is self-adhering, and installation consisted of cutting, laying, and rolling the fabric. A pickup truck with dual tires was used to roll the fabric. Figure 19 is a photograph of Glassgrid placed on a transverse crack.

The Glassgrid did not bond well to the existing surface. The boot truck, belly dump, and paving machine all pulled up the paving fabric. The bond was poorer than with the Pavprep, and in some instances the fabric was pulled completely off of the surface. Just a small amount of asphalt cement would cause the fabric to be picked up. Hot asphalt concrete was spread under equipment tires in an attempt to keep the fabric from being picked up, but this did little to help.

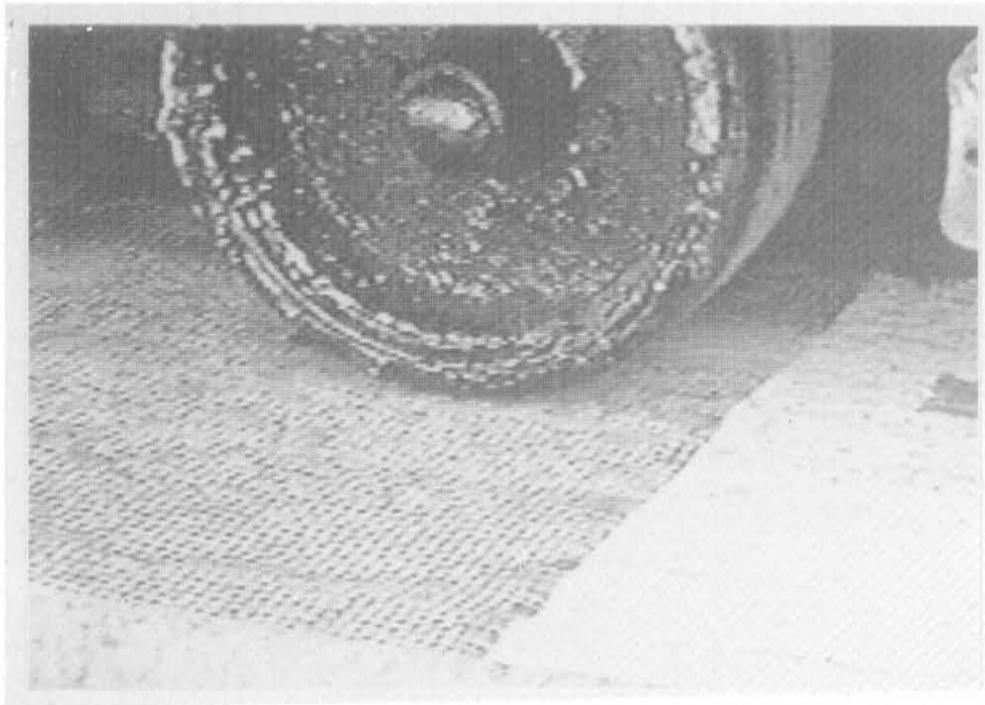
**Figure 20** Glassgrid Placed Without Binder Coat.

The bonding problem was thought to be a result of Glassgrid's mesh structure. Because of this structure there is limited surface area in contact with the existing surface. A milled surface amplifies this limit. Even after the binder coat was changed from AC-30 to emulsion, the fabric still picked up. Better results came from completely eliminating the tack coat, as shown in Figure 20. In an attempt to increase the bond, a pneumatic roller was employed rather than a pickup truck to roll the fabric. However, no bonding improvement was noticed.

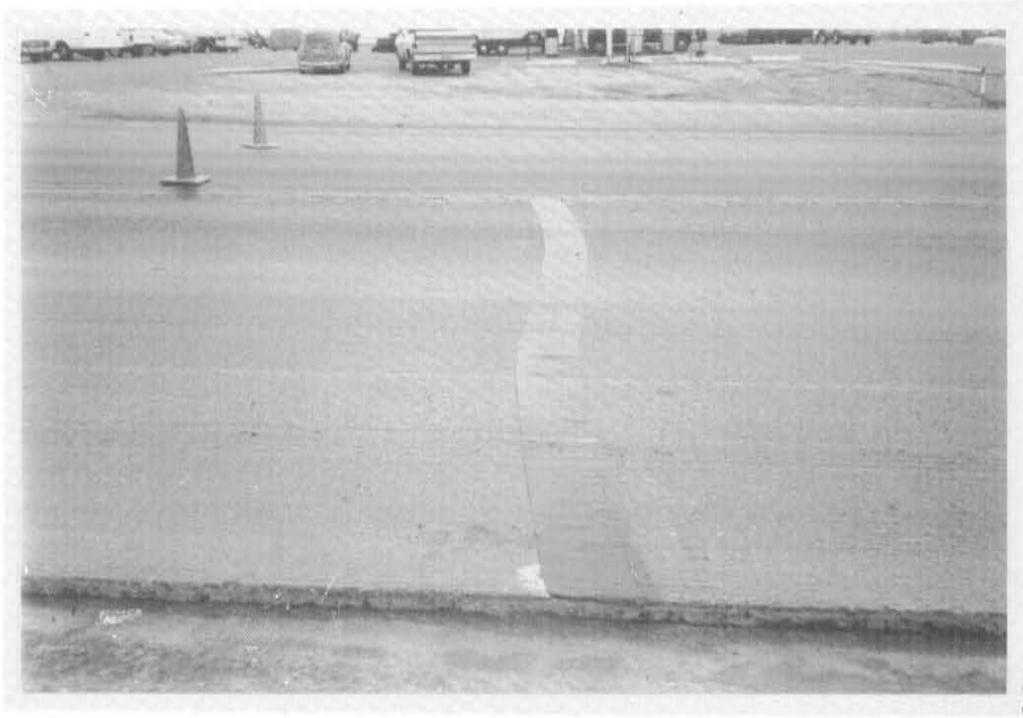
**Figure 21** 12-in. Tapecoat Placed on a Transverse Crack.

Eight transverse cracks, crossing 472 ft. of roadway, were treated with 12 in. wide Tapecoat. Also, 93 ft. of random cracks were treated with 4 in. wide Tapecoat, and 52 ft. of random cracks were treated with 12 in. wide Tapecoat. Refer to Figure 3 for locations. Like Glassgrid, Tapecoat is self-adhering, and as such the installation required cutting the material, peeling off the backing to expose the adhesive surface, and rolling the placed fabric. A pickup with dual wheels was used to roll the fabric. Figures 21 and 22 show 12 in. and 4 in. Tapecoat installations.

As with the other fabrics, the Tapecoat curled up beneath the tires of construction equipment that had AC-30 tack built up on their tires. The problem occurred with less frequency than with either the Paveprep or the Glassgrid, and upon changing the AC-30 binder coat to emulsion the Tapecoat no longer picked up under tires.

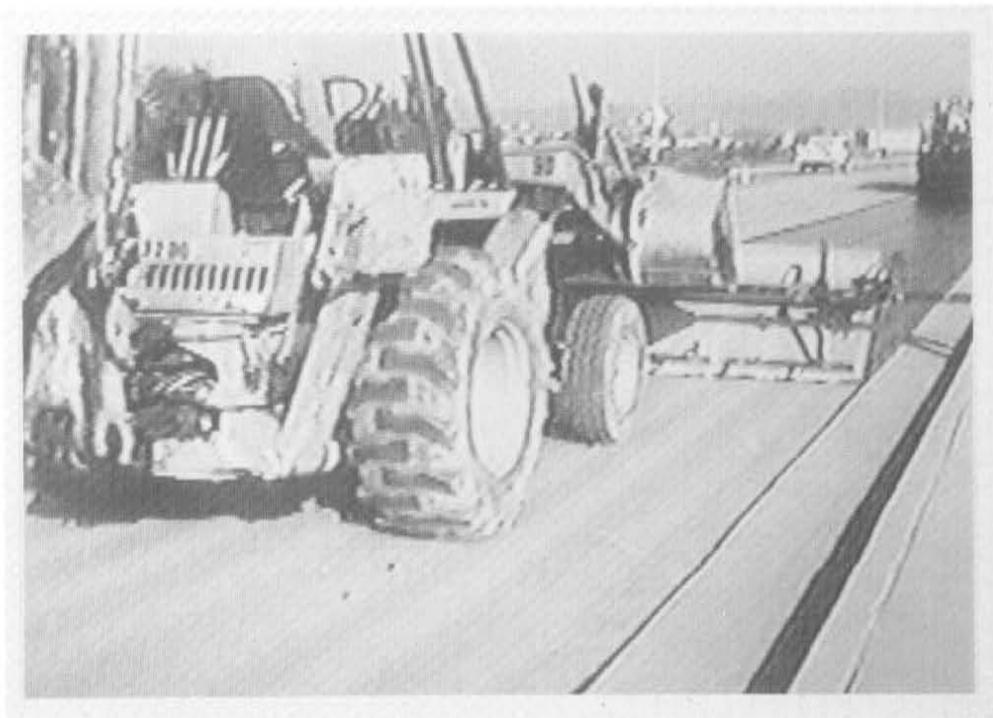
**Figure 23** Placement of the Travira Spunbound Fabric.

On the east side of the construction project, from stations 56+61 to 79+78, a pavement reinforcing fabric called Travira Spunbound was used. The fabric was laid covering the full width of the roadway for the full length of the remainder of the project. The fabric meets ADOT specifications, and is not considered a part of the test section, however, its performance was also informally monitored.

For the installation of the Travira Spunbound, a tack coat of AC-30 was placed on the existing milled surface at a rate of 0.3 gal./sq. yd.. The fabric was then placed using a fabric installer that was attached to the loader bucket of a backhoe. Figure 23 is a photo of the fabric being placed on the milled surface. The tack coat was applied in 12 ft. lanes and placed 6 in. wider than the fabric. Then the fabric was placed 6 in. wider than the overlay paving passes (i.e. the fabric overlapped into the adjoining lane(s)). The beginning and ends of the rolls were overlapped 1 ft. and tacked. Wrinkles in the Travira Spunbound greater than 0.5 in. high were cut and the material pulled so that it overlapped.

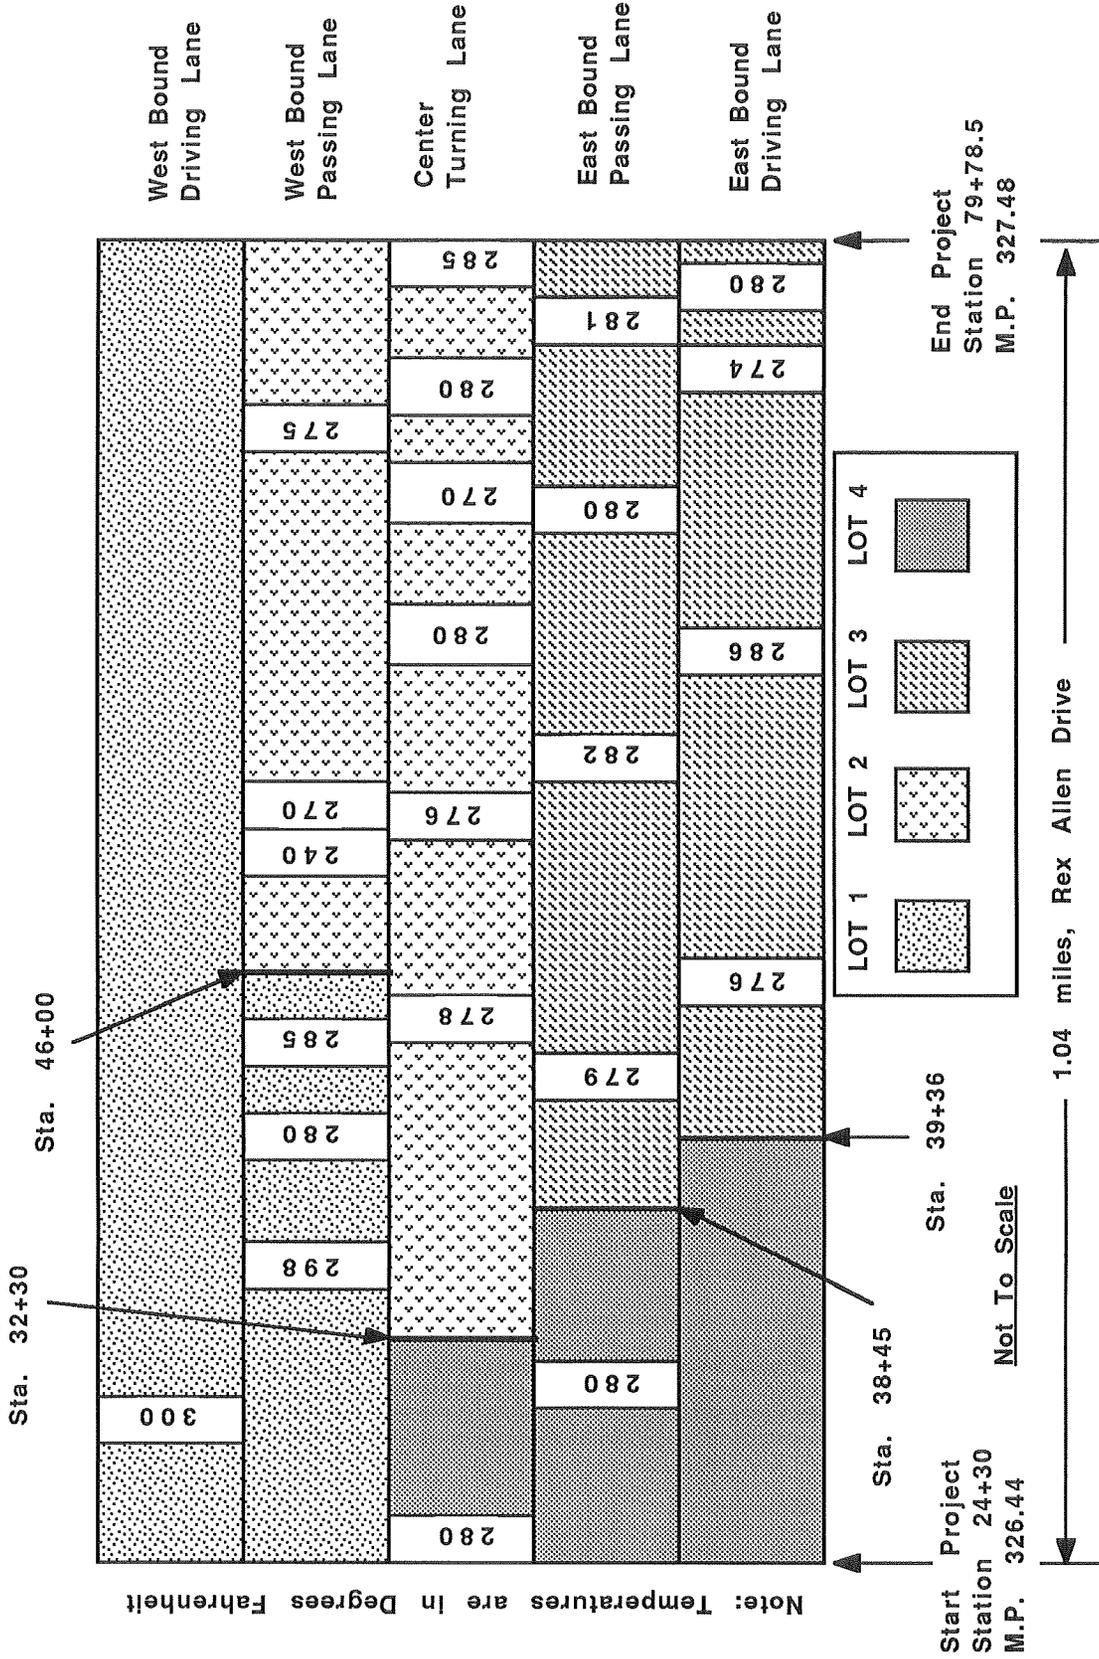
Figure 28 Asphalt Concrete Placement Temperatures.

Table 2 presents the temperature of the asphalt concrete in relation to the date and location it was placed. The information is illustrated in Figure 28. Daily weather conditions during construction are presented in Table 3.

The boot truck carrying the AC-30 asphalt cement was not able to keep the asphalt within the desired temperature range of 320° F to 350° F. On the first day of paving (Aug. 8) the temperature of the AC-30 was recorded at 310° F. For the rest of the project the temperatures were much lower. On August 10, at approximately noon, the temperature of the AC-30 was observed at 225° F, and a sample taken from the end nozzle showed the temperature at 205° F. It was discovered that the level of asphalt in the truck was below the heating coils, and as a result, that amount of AC-30 could not be heated any further with the equipment that was being used.

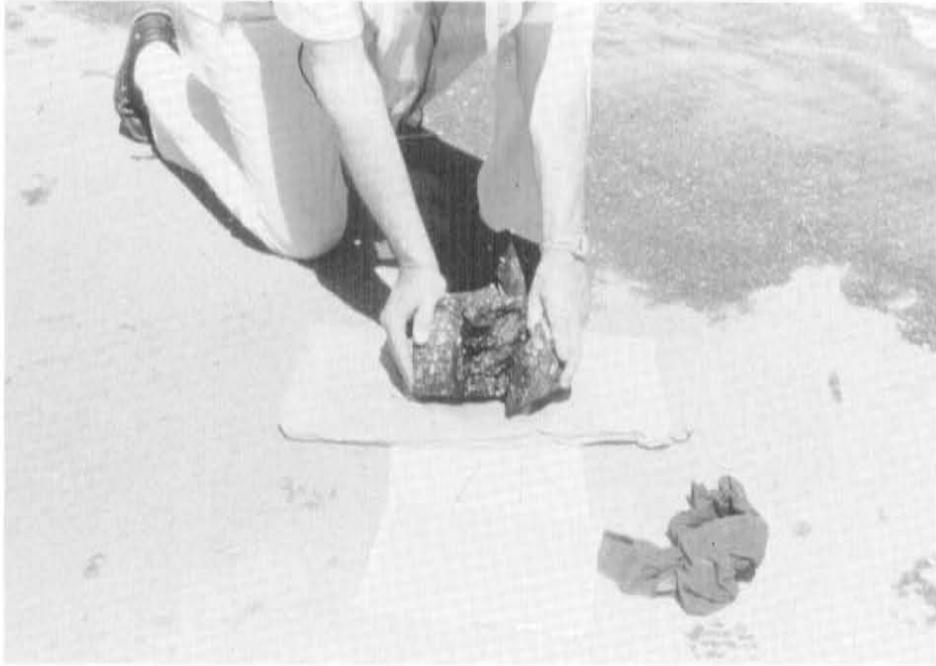
**Figure 30** Core Sample of Paveprep Treated Crack.

As it turned out, each of the core sample cracks was observed to have began in the original pavement and propagated through the paving fabric. As such, only two samples of each treatment were necessary. Figures 30, 31, and 32 demonstrate core samples with Paveprep, Glassgrid, and Tapecoat in place. The results of the core sampling confirmed the validity of the results of the field surface crack evaluations.

From the core samples, it was observed that the fabrics had remained intact over the cracks, and showed no sign of distress. This is reasonable as the moduli of the fabrics were such that they were acting as "strain-relieving" interlayers, rather than "reinforcing" interlayers. Button and Lytton define a reinforcing fabric or grid as one in which the modulus is more than 5 times that of the surrounding asphaltic concrete<sup>11</sup>. The modulus of Glassgrid is reported to be 10,000 psi. The manufacturers of Paveprep and Tapecoat did not provide the moduli of their product, but it is apparent that they are much less than that of the AC at this location. Previous laboratory tests have shown three distinct modes of failure for fabric and grid treated overlay samples. These are illustrated in Figure 33.

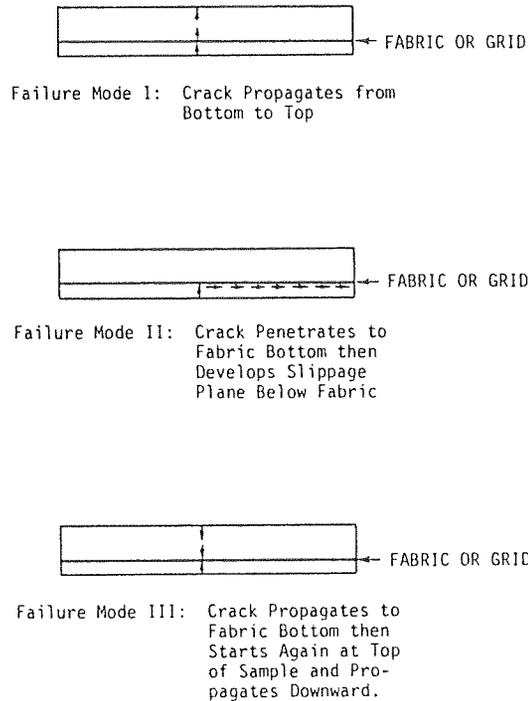
**Figure 33** Modes of Fabric and Grid Treated Sample Failure<sup>11</sup>.

Failure modes I and III occur when the material acts as a "strain-relieving" layer. This is consistent with the results obtained from this experimental project. The fabrics elastically stretched to accommodate the propagation of the crack. It is unknown whether the crack propagated up from the fabric to the surface, or down from the surface to the fabric.

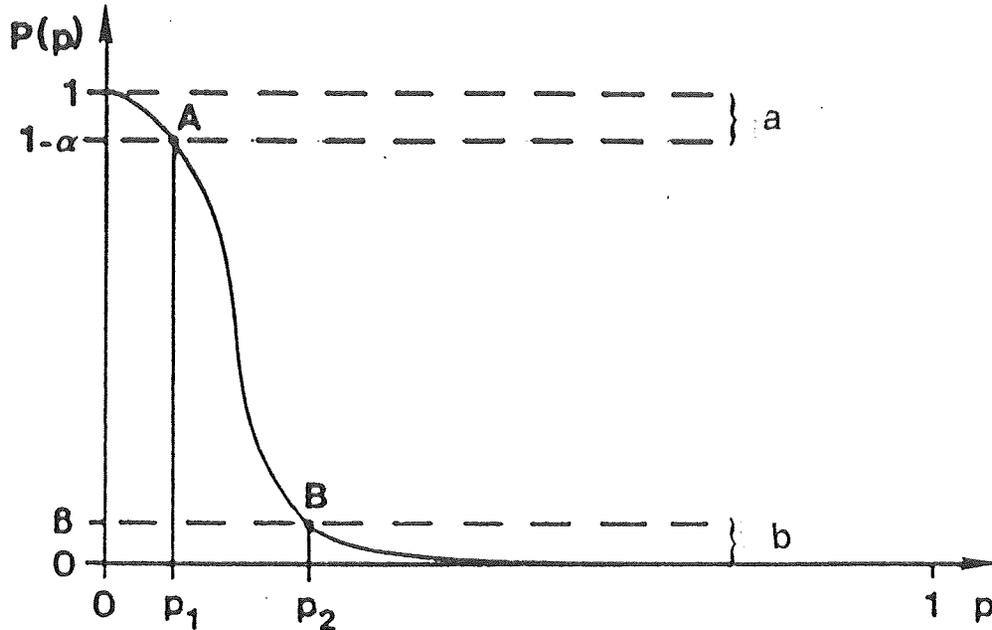
Figure 1 An OC-curve (From Stoodley et. al.)

The ability of a sampling plan to discriminate between acceptable and not acceptable lots is often developed using an Operating Characteristic (OC) Curve.

Chapter 5 of Applied Statistical Techniques by Stoodley, Lewis, and Stainton further describe how given the points  $p_1$  and  $p_2$ , and the producers risk  $(1-a)$  and consumers risk  $(b)$  can be used with the  $X^2$  distribution to determine the above mentioned parameters  $n$  and  $c$ .
