ARIZONA DEPARTMENT OF TRANSPORTATION

REPORT NUMBER: FHWA-AZ-7904

PERFORMANCE OF CONCRETE JOINT SEALANTS IN HOT CLIMATES

Final Report

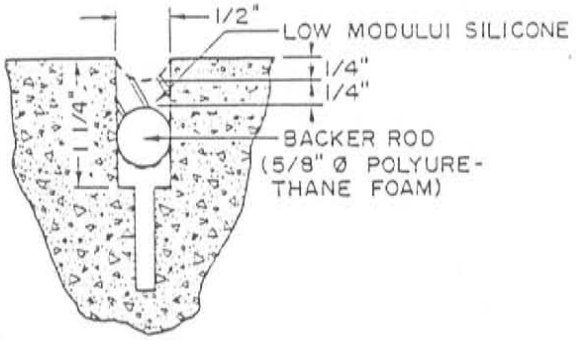
FIGURE 4 - DOW 888 JOINT

Dow 888, unlike the other sealants used on this project, is cold applied. Prior to the placement of the joint sealant, a 5/8" diameter polyurethane foam backer rod was placed in the joints to a depth of 7/8" below the pavement surface (Figure 4).

The performance of the 24 joints sealed with Dow 888 has been good. The sealant set up quickly to a tack free states, remained firm and resilient, and appeared to be unaffected by temperature variations. There has been no embedment of incompressibles to date. When surveyed in February 1982 (approximately two and one-half years after installation), all of the 24 joints were in excellent condition. In the survey conducted in June 1984, seven joints were noticed in which the sealant was too high and had pulled away from the joint wall. In each case the torn length occurred in the wheel path and was less than ten percent of the length of the joint. Heavy infiltration of sand and larger incompressibles was noted in these area. Additionally, a few other areas were noted in which the sealant was flush with the pavement surface. However, apart from these small areas, the sealant is well bonded to the sides of the joint walls. In order to test the ability of the sealant to bond to the concrete a small transverse cut was made and the sealant was pulled out of the joint. Except in the poorly sealed areas the sealant failed in cohesion rather than adhesion. In 1987 a final evaluation was performed and the joints were in the same condition as the 1984 evaluation. Roughly 20 percent of the joints had small bond failures of 1' or less caused by the sealant being too high.

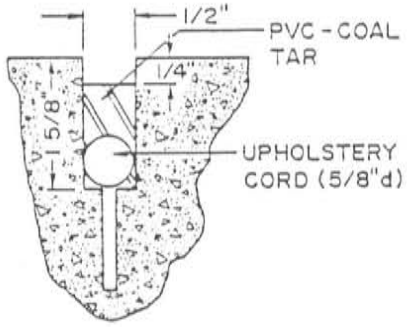
FIGURE 5 - SUPERSEAL JOINT

The Superseal 444 was placed by a subcontractor under the supervision of the manufacturer's representative. Prior to sealant placement, an upholstery-cord backer rod was placed in the joints (Figure 5). The sealant was heated in a double-boiler melter-kettle (Figure 10) to above 275°F. The hose, wand, and nozzle used to place the material was similar to that used in the Dow 888 placement. The sealant flowed quickly into the joints with no apparent problems. The temperature of the sealer was 290°F and the air temperature at the time of placement was 90°F.

The appearance immediately after construction of the joints sealed with Superseal 444 was very good. However, after about one and one-half years of service, the sealant hardened, particularly at the top, and cracks were noticed in the top 1/8" of the joint seal. At the same time the bond between the sealant and the sides of the joint began to deteriorate in the top 1/8" of the seal. Debris had also collected in most of the joints and the survey performed in February 1982, showed slight embedment of incompressibles in seven of the seals. Below the top 1/8" of the seal, the bond between the joint walls and the sealant is in good condition. At one joint, however, a four foot long pull-out occurred in October 1981. The ductility of the sealant is apparently influenced by temperature. The ambient temperature at the time of the survey was approximately 110^{0}F, and during this survey it was noticed that the cracks formed in the sealant during the winter had closed due to the contraction of the joint and softening of the sealant. In March of 1987 it was noted that the top 1/4"-1/2" of the sealant was heavily weathered. There was a slight problem with incompressibles and the joint was not sealed on the surface.

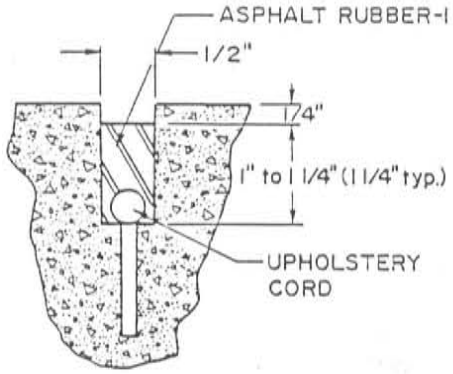
FIGURE 6 - OVERFLEX JOINT

The equipment used to install the Overflex-MS2 was the same as that used to install Superseal 444. A rubberized asphalt blend of AR-2000 asphalt and TPO-44 was blended and allowed to react in a double-boiler melter-kettle on site. The sealer was placed by the subcontractor at a temperature of 375°F. The air temperature at the time of placement was 85°F. A typical cross section of the joint is shown in Figure 6.

The Overflex-MS2 set up quickly. The day after installation the surface was found to be firm, resilient, well bonded to the side walls and capable of rejecting incompressible material pressed into it. However, debris collected easily in these joints and as early as May 1980, embedment of incompressibles was noticed in almost all of the joints. In the survey conducted in March 1981 the embedment of incompressibles in the sealant had reached severe proportions (from 70% to 100% of the length of the joint). The sealant had also hardened, particularly where incompressibles were embedded. In the survey conducted in February 1982, it was noted that all of the joins

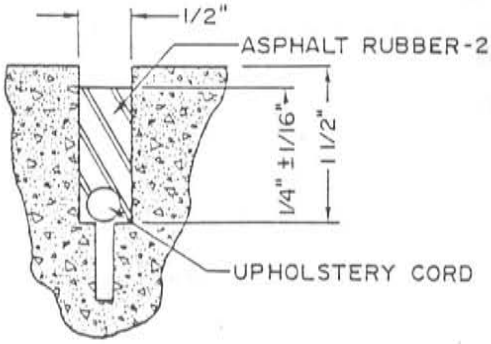
FIGURE 7 - ARCO JOINT

The manufacturer placed their own plant blended rubberized asphalt. The first ten joints were placed using a 1" placer nozzle which produced an occasional overfilled or underfilled joint. After the tenth joint, a smaller nozzle was used which produced better results. The equipment used was similar to that used to install the Superseal 444 joint sealer. The material was placed at temperatures varying from 350°F to 395°F. The air temperature at the time of installation was 90°F. An upholstery cord was used to prevent the sealant from seeping into the lower recess of the joint (Figure 7).

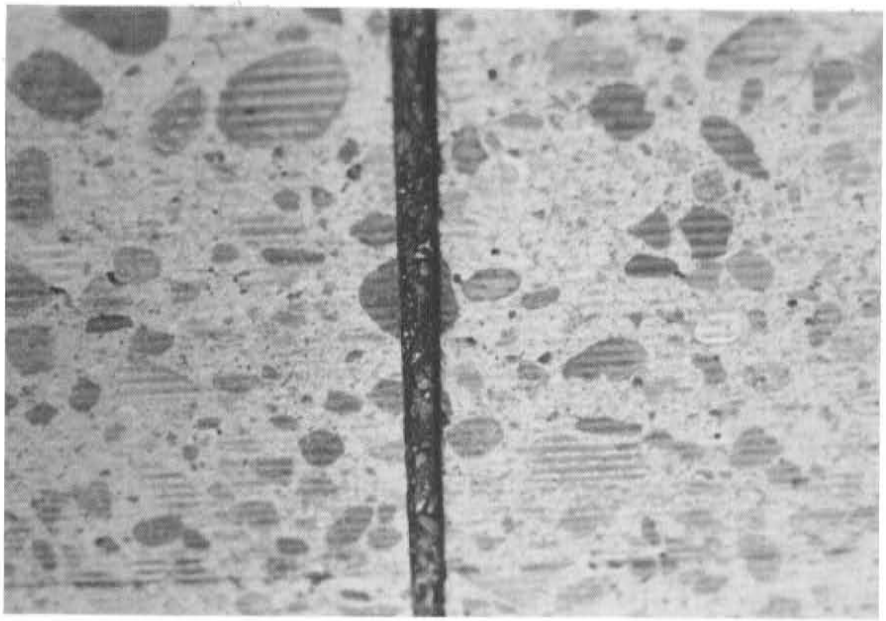
were brittle, however, no cracks were noticed and a good bond between the sealant and the joint walls was maintained. During the subsequent summer surveys, the sealant had softened considerably and continued to collect incompressibles (Figure 12). In March of 1987 the material was brittle and full of incompressibles.

FIGURE 12. - INCOMPRESSIBLES EMBEDDED IN OVERFLEX-MS2
