I-10, 35TH AVE TO SKY HARBOR BLVD PHOENIX CORRIDOR SAFETY STUDY

FINAL REPORT

Kittelson & Associates, Inc.
Lee Engineering
Works Consulting
DiExSys

April 2015

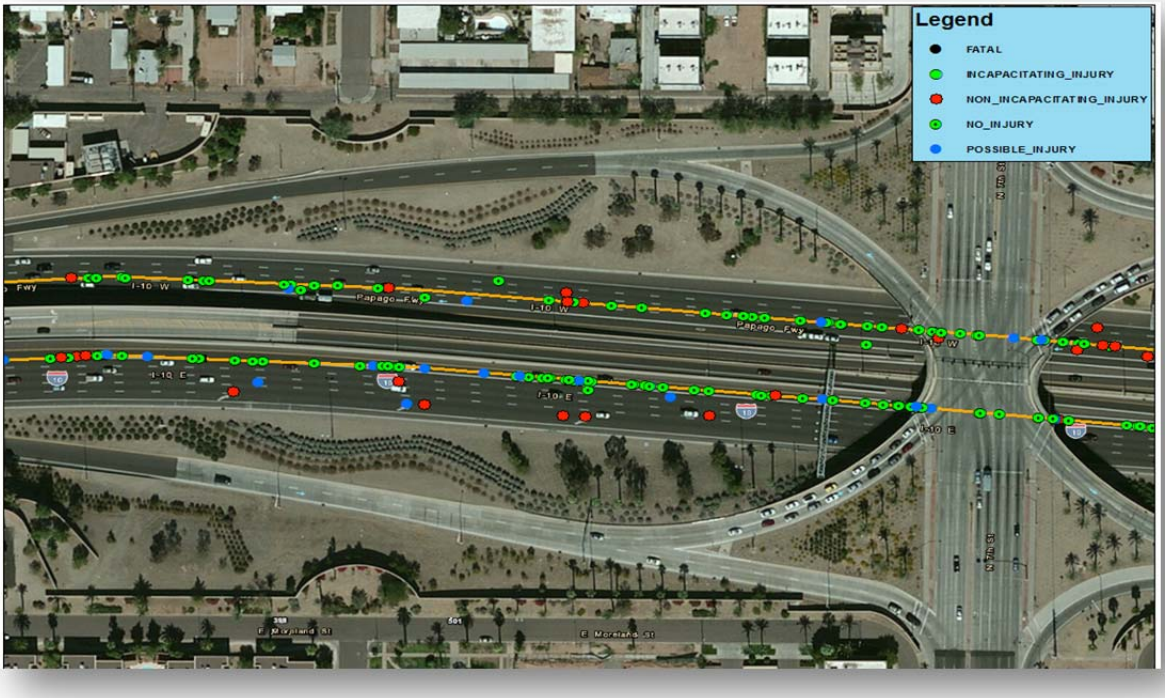
Figure 10. Distribution of Crashes by Severity (Deck Park Tunnel to 7th St)

Using the GIS crash database, the distribution of different crash attributes including severity, manner of collision, first harmful event, lighting condition, and weather condition were reviewed. Figure 10 shows the crash distribution for a segment by severity type. FMS and HPMS counting stations were added to the database so that traffic volume and operations information can be included in the review of crash trends.
